Program Bulletin

CUSTOMER SATISFACTION PROGRAM

SUBJECT: Exterior Door Handle Binds or Sticks

MODELS: 2015 Chevrolet Impala

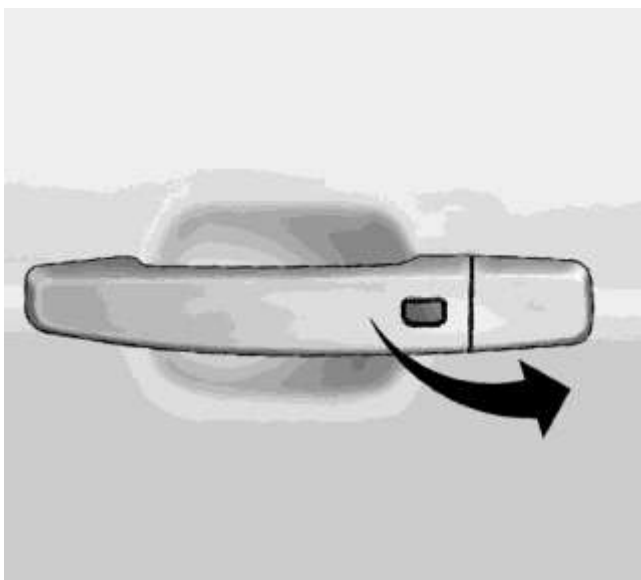
4063151

Direction of pull for door handle inspection.

- 2. Grasp door handle towards the rearmost edge. Quickly pull the door handle outward and at a rearward angle to check for binding or sticking. Binding or sticking may occur at the maximum travel of the handle.
 - 2.1 Repeat five (5) times.
 - 2.2 If no problem found, proceed to next handle.
 - 2.3 If no problem found on all handles, proceed to Step 4.
 - 2.4 If any handle binds or sticks, proceed to Step 3.

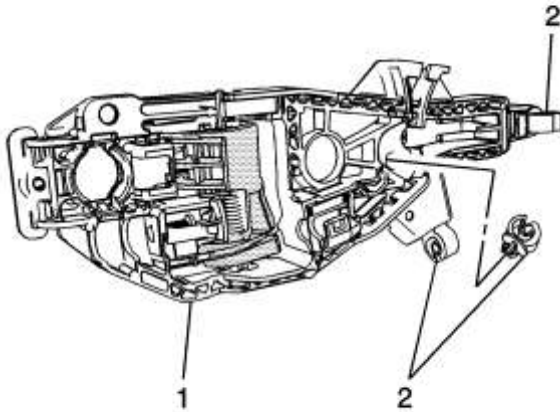
2755846

Door outside handle bracket (1) shown with clips (2), mounted inside door.

Note: Door latch does not have to be removed to replace the bracket in either front or rear replacement procedures. Unclip latch cables during removal.

- 3. Replace door handle bracket on binding or sticking handle. Refer to *Front Side Door Outside Handle Bracket Replacement* in SI. For replacement of rear door handle bracket, refer to *Rear Side Door Outside Handle Bracket Replacement* in SI.

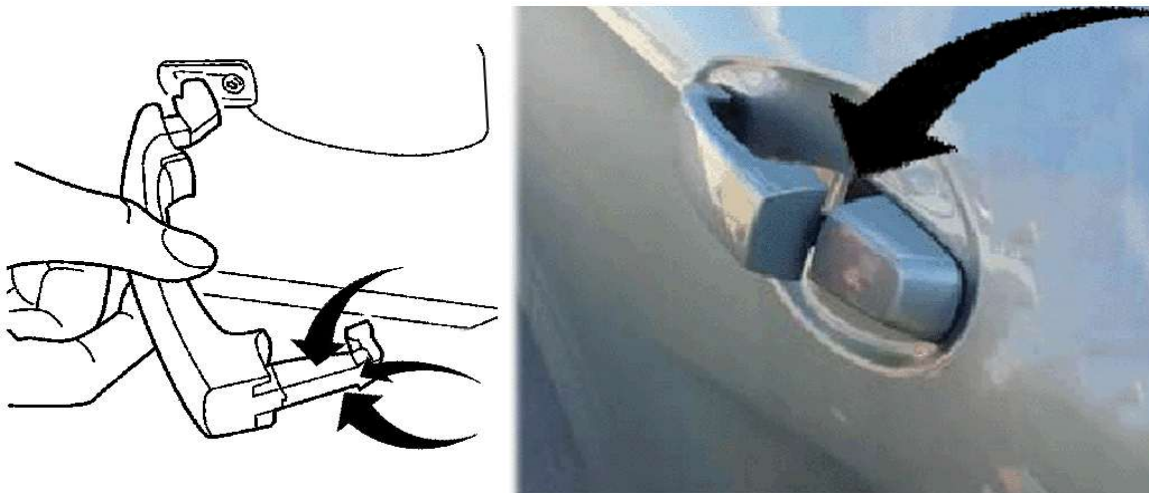
4070469

Lubrication points (arrows) on door handle unpainted black tower leg. (Exploded view shown for detail, disassembly not required.)

NOTE: A small amount of lubricant should be applied to the black tower leg of the handle. Use only the AC Delco Super Lube Lubricant identified in the Parts Information section. Substitutions are not allowed.

4. Using a Q-tip or suitable applicator, lubricate all door handles, passive or non-passive entry. Thoroughly apply lubricant on top, bottom and rearmost side of the tower leg.
5. Cycle handle five (5) times. Move handle throughout the range of travel, applying light pressure towards front and rear during cycling to work lubricant into the mechanism.
