Service Bulletin

PRELIMINARY INFORMATION

Subject: Wind Noise and/or Water Present in Left Lower Corner of Windshield

Models: 2015 Chevrolet Volt
Built Between November 23, 2014 and February 18, 2015

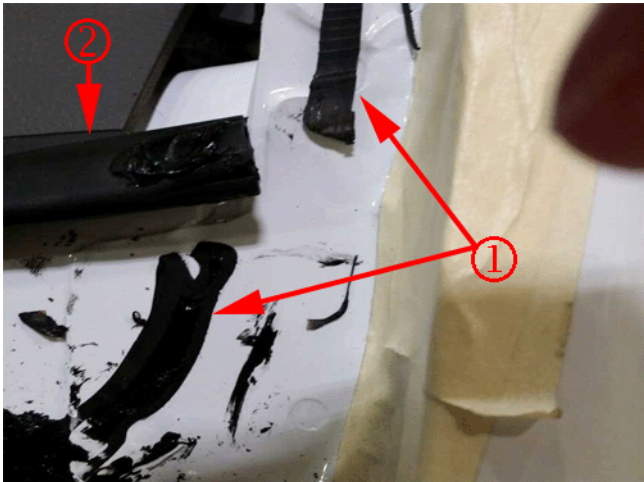
1. Windshield Urethane Sealant

2. IP Seal

This may be caused by the IP seal being improperly installed on the left side of the IP when the windshield was installed during production as illustrated above.

This may also be caused by the windshield urethane sealant being struck during installation of the windshield.

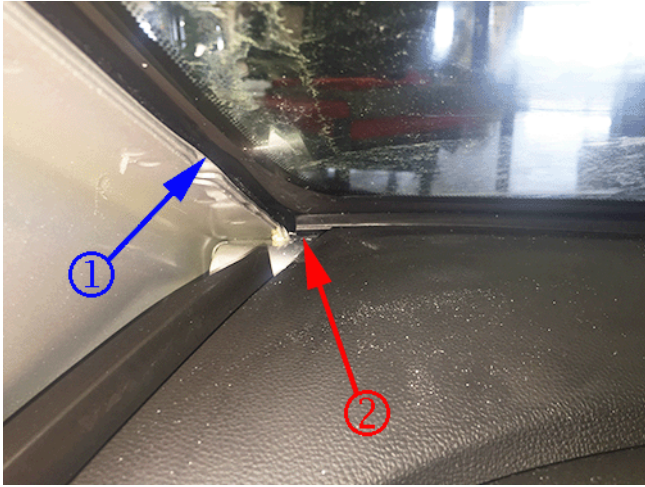
1. Windshield Urethane Sealant

2. IP Seal

2. Visually inspect IP seal to verify that it is installed correctly, and there is a clean seal between the urethane sealant and the windshield as illustrated above.

Note: There should be no overlap between the windshield urethane sealant and the IP seal.

3. If the IP seal and the windshield urethane sealant are overlapped, remove the windshield. Refer to Windshield Replacement in SI.

4. With the windshield removed from the vehicle, cut back the excess IP seal that caused the overlap.

5. Reinstall the windshield. Refer to Windshield Replacement in SI.
