Service Bulletin

PRELIMINARY INFORMATION

Subject: Pop or Click Noise When Front Seat is Moved Forward or Backward

Models: 2013-2015 Chevrolet Equinox
2013-2015 GMC Terrain
Equipped with RPOs AE8 or AH8

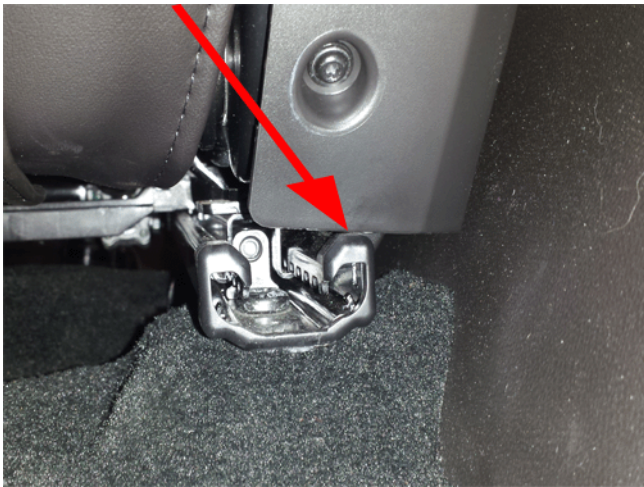
Some customers may comment on a popping or clicking noise from the seat when the seat is travelled forward or backward.

This may be caused by interference between the seat inner and/or outer finish cover and the end of the seat track when the seat is in the full down position or the seat is occupied.
