Service Bulletin

Subject: Intermittent Engine Stall and/or Cranks No Start with No DTCs

Models: 2013-2014 Chevrolet Spark

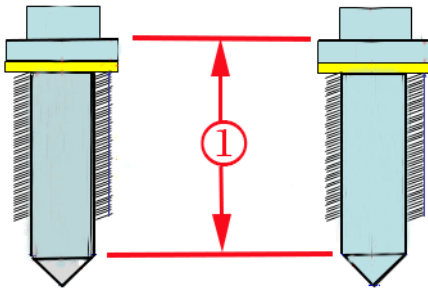
This condition may be caused by the ignition coil ground G107 bolt being too long causing the bolt to bottom out before generating the proper torque specification, creating a poor contact on the ground wire, circuit 150 (black).

3. Measure the length (1) of the bolt as illustrated above.
 - The correct length is approximately 16.4 mm (0.65 in).
 - The incorrect length is approximately 20.8 mm (0.82 in).
4. If the bolt is the correct length, inspect the bolt and ground wire for possible cause of the engine stalling and/or crank with a no start condition. If no root cause was found, reinstall the original bolt and continue diagnoses. Skip to step 6. Refer to SI for further diagnostics.
5. If the bolt is the incorrect length, replace the bolt with a shorter bolt, P/N 11561025.
6. Reinstall G107 bolt.
7. Reinstall the radiator surge tank.
8. Verify the condition as been corrected.
