Service Bulletin

PRELIMINARY INFORMATION

Subject: Rear Compartment of Front Floor Console Stuck in Open/Closed Position

Models: 2013-2015 Cadillac ATS
2013-2015 Cadillac CTS Sedan (VIN A)

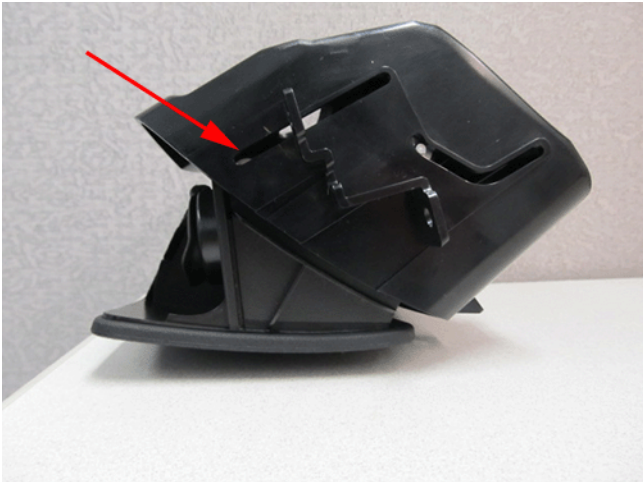
Some customers may comment that the rear compartment of the front floor console is stuck in the open or closed position and/or is binding during operation.

This may be caused by the front floor console rear compartment alignment pins becoming unseated. This can occur if the rear compartment is pushed or kicked.

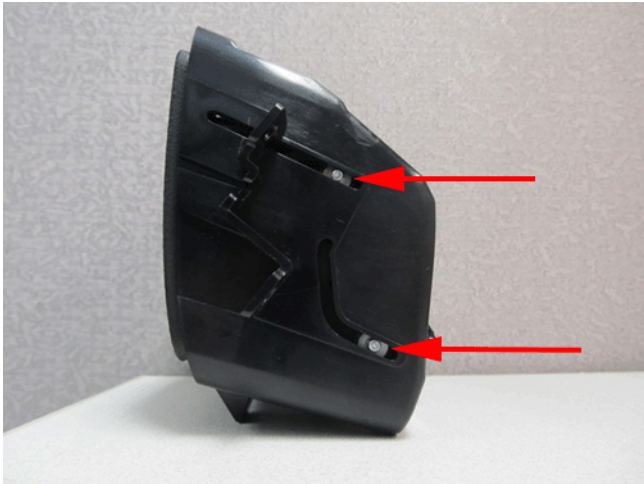
3. Inspect the 4 alignment pins for being out of place. If any of the alignment pins are out of position, the mechanism can be gently put back into position.

4. Visually inspect for any broken components. If any components are broken, replace the rear compartment.

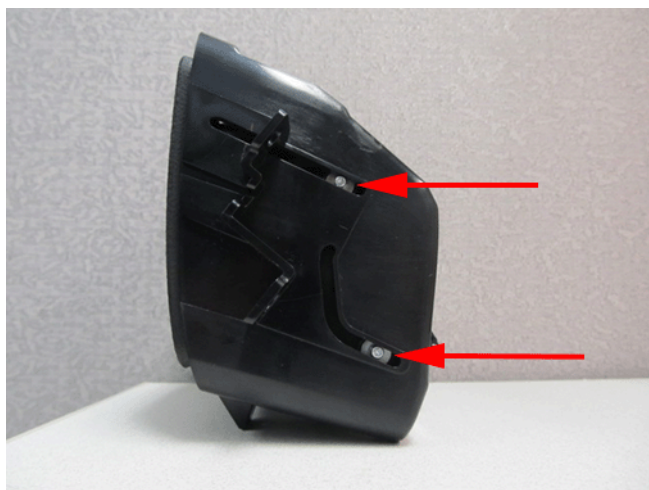
3. Inspect for two metal pins on each side of the housing for damage.

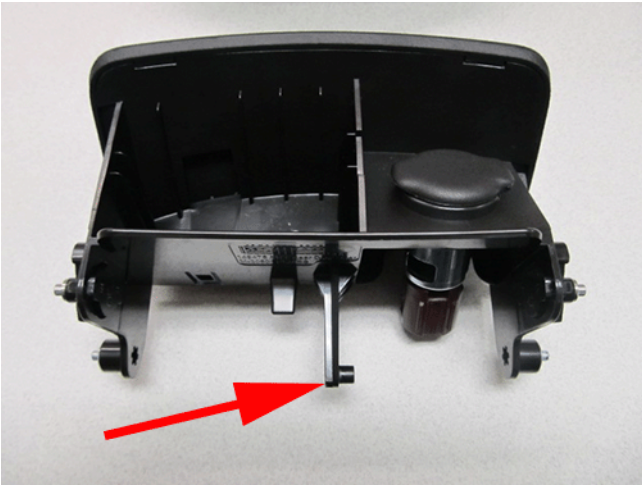
4. Inspect the arm on the back of the compartment for damage.

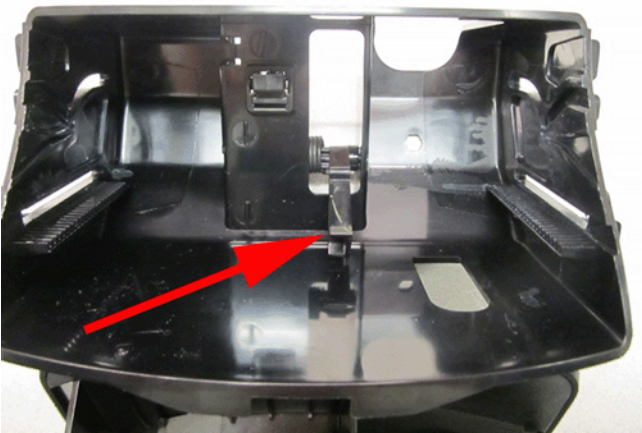
5. Inspect the spring loaded lever in the housing for damage.
6. If all parts are undamaged, using a trim stick to lower the spring loaded lever in the housing from the back.

Note: If any components are damaged, replace the rear compartment.
