## Oily, shiny surface or white residues on leather or imitation leather seat covers

| Topic number | LI91.18-P-060470 |
| Design group | 91.18 Seat covers |
| Validity | Model series 205 with equipment code: 101A / 105A / 118A / 128A / 131A / 141A / 151A / 158A / 201A / 215A / 218A / 221A / 225A / 231A / 238A / 241A / 248A / 251A / 268A |

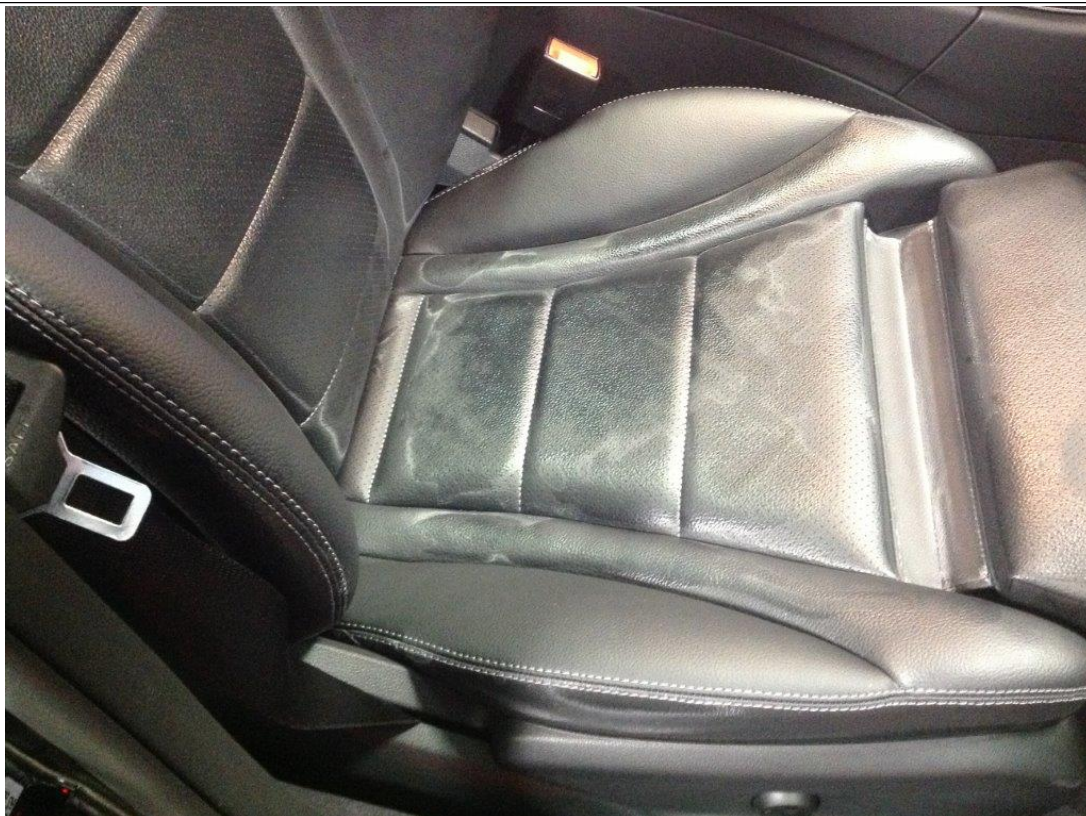
IMG\_2054.jpg:

- In cold weather the surface of the imitation leather can appear oily or shiny (Pic2, Pic3).
- When the material warms up again, the substance evaporates and this can result in white edges on the surface (Pic1)

| Attachments | |
|---|---|
| IMG_2054.jpg | Pic1 - Seat cover with white residues |

- Driver seat: Replace seat cushion cover, backrest cover and head restraint
- Front passenger seat: Replace seat cushion cover, backrest cover and head restraint; IMPORTANT: Contrary to the instructions in the WIS documents 'ET Kit replacement', the seat cushion cover on the passenger side may be replaced in the same way as the driver seat.  
To receive only the seat cushion cover, order:

Please clean the seats with warm soapy water solution (do not use aggressive cleaning agents) before releasing to customer.

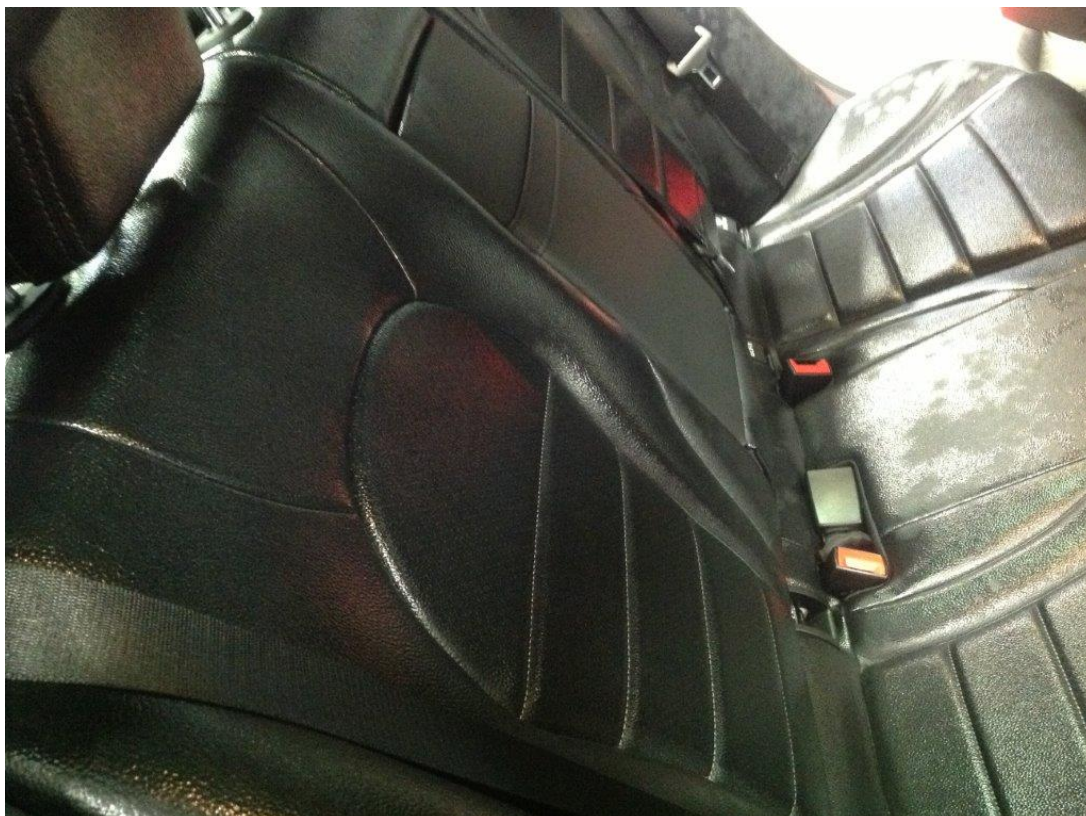
IMG\_2055.jpg:

| Attachments | |
|---|---|
| IMG_2055.jpg | Pic2 - Seat cover oily/shiny |

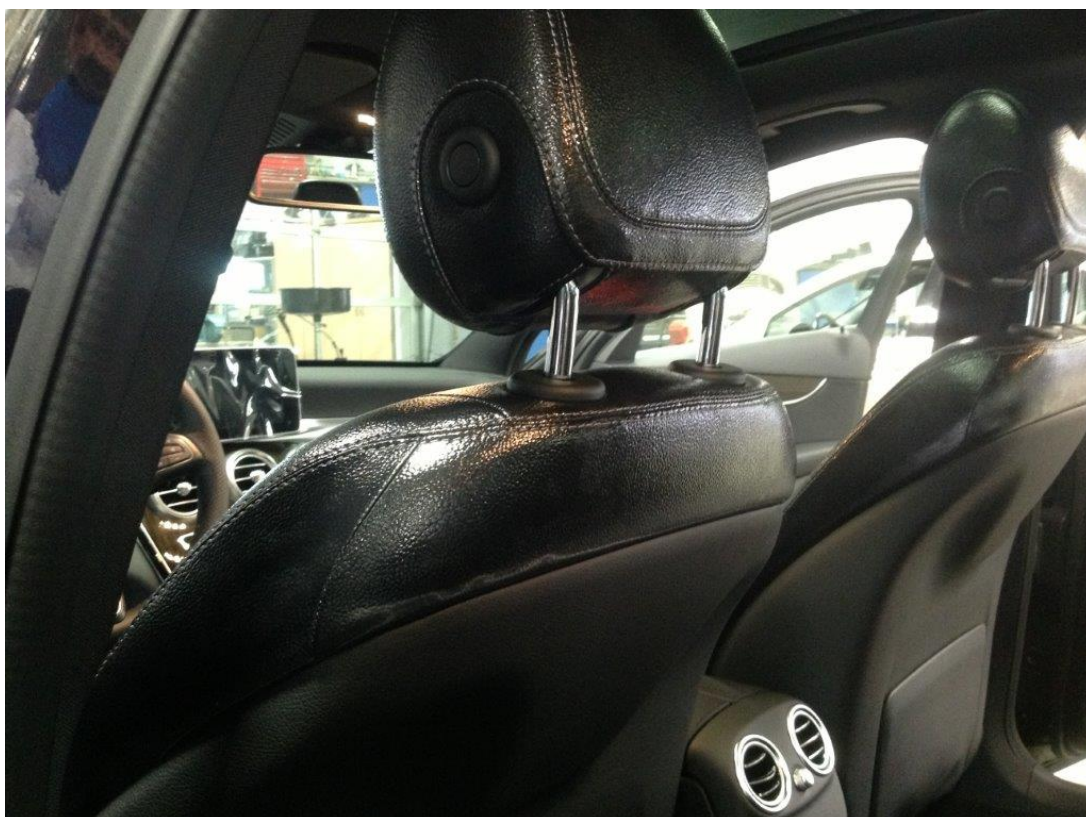
IMG\_2058.jpg:

| Attachments | |
|---|---|
| IMG_2058.jpg | Pic3 - Head restraint cover oily/shiny |
