## Light gap between roller blind and rear door window frame trim in upper position

| Topic number | LI72.12-P-060707 |
| Design group | 72.12 Rear door |
| Validity | BR222 with code 297 |

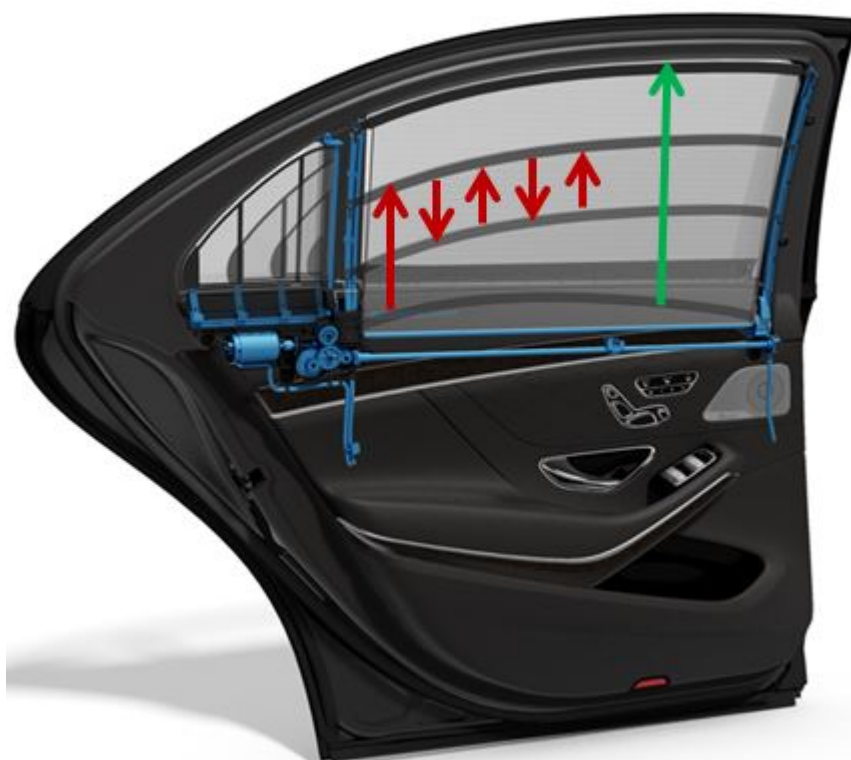
Bild 1.JPG:

Light gap between roller blind and rear door window frame trim in upper position.

When the roller blind is being raised, if an obstruction is detected in the last 10mm (e.g. a trapped foreign object), then this is saved as the uppermost position of travel.

Normalization of rear door roller blind; see graphic, Figure 1.

1. Move roller blind to halfway position.
2. Operate a short distance down, up, down and up again.
3. Move roller blind all the way up. This completes the normalization process.
