## Oily, shiny surface or white residues on Leather or MB-Tex seat covers

| Topic number | LI91.18-P-060470 |
| Design group | 91.18 Seat covers |
| Date | 03-17-2015 |

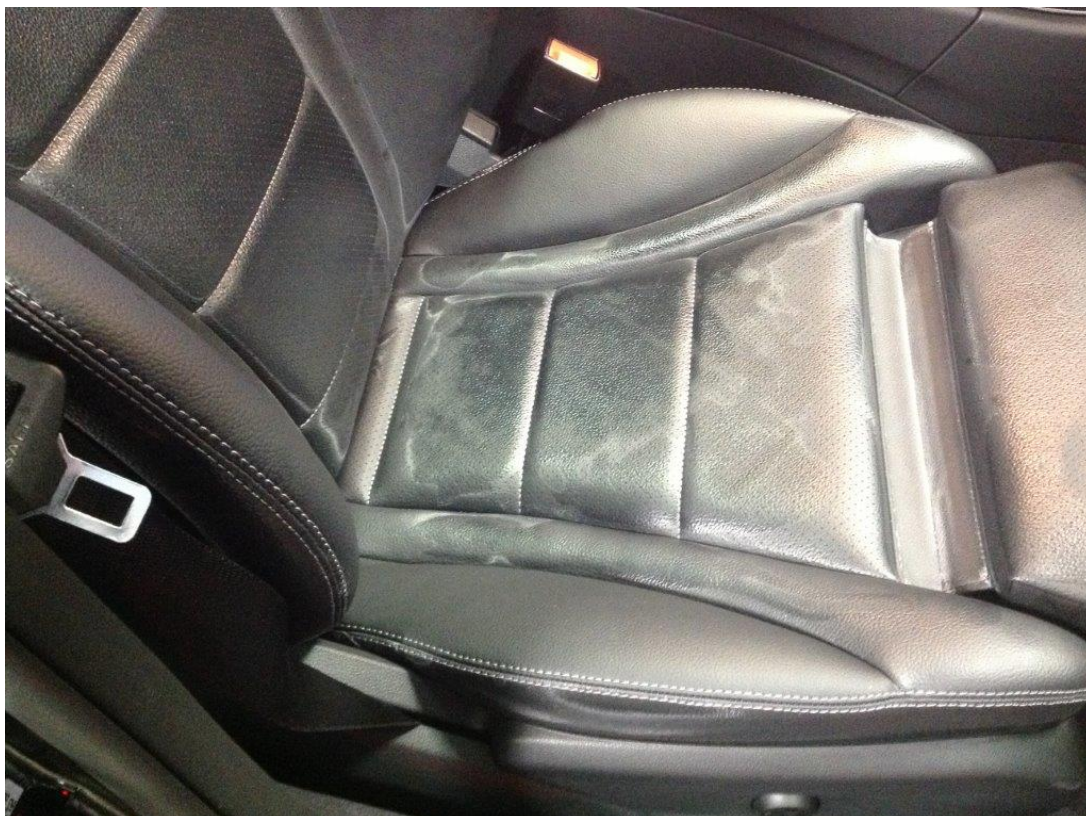
IMG\_2054.jpg:

- In cold weather the surface of the imitation leather can appear oily or shiny (Pic2, Pic3)
- When the material warms up again, the substance evaporates and this can result in white edges on the surface (Pic1)

| Attachments | |
|---|---|
| IMG_2054.jpg | Pic1 - Seat cover with white residues |

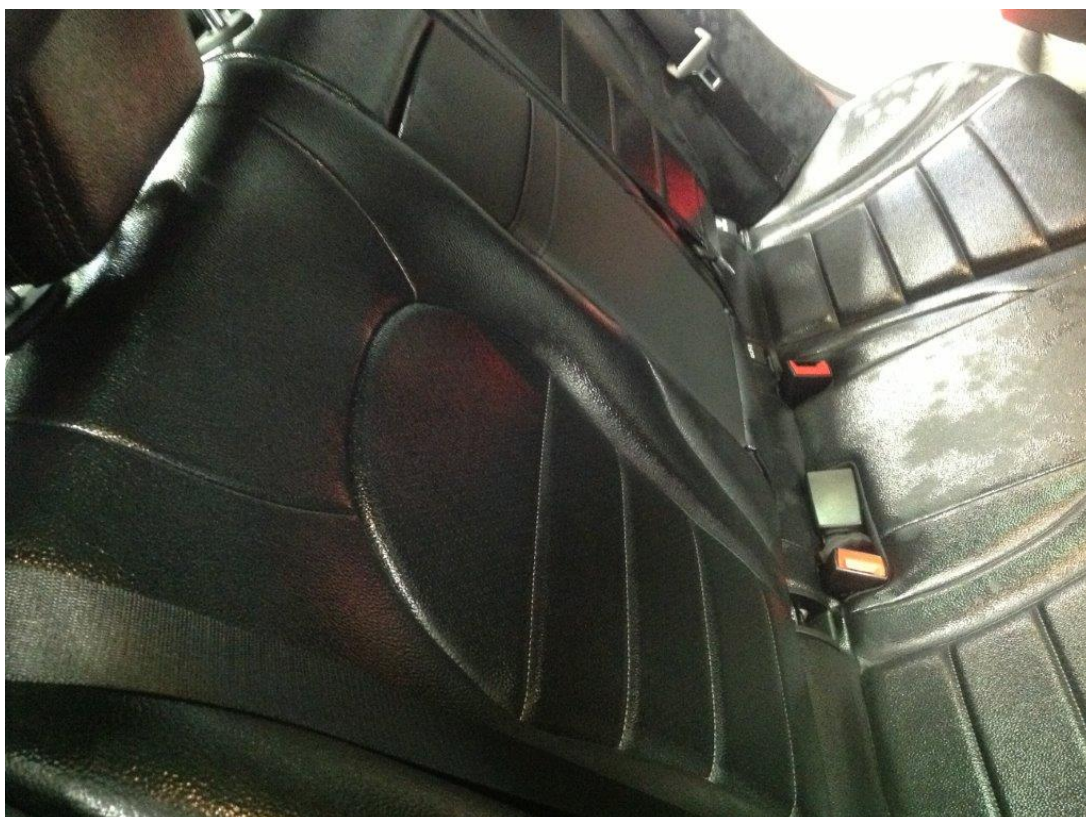
IMG\_2055.jpg:

| Attachments | |
|---|---|
| IMG_2055.jpg | Pic2 - Seat cover oily/shiny |

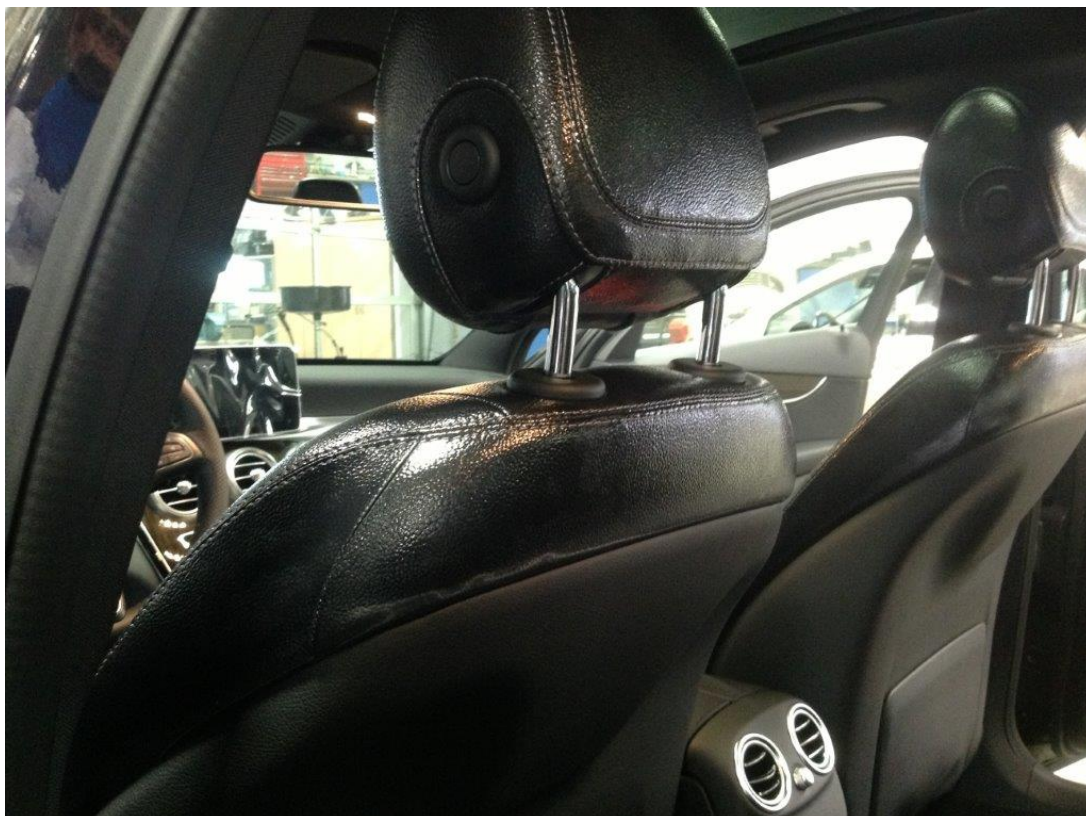
IMG\_2058.jpg:

| Attachments | |
|---|---|
| IMG_2058.jpg | Pic3 - Head restraint cover oily/shiny |

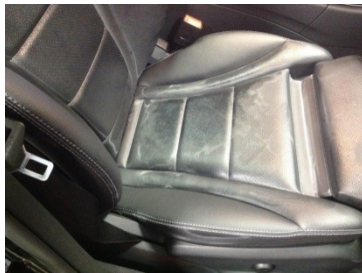
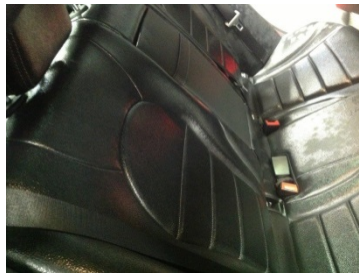
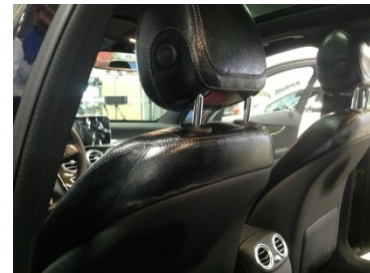
*The Q&A below is intended help address potential C-Class BR205 customer concerns with seat cover residue. Please see examples below.*

⇒ Due to production deviation in manufacturing, at temperatures below 32° F along with certain elevated humidity conditions, the plastisizer used in the seat material may “sweat” and gather on the seat surfaces.
