## Water deflector to panoramic roof - narrow opening

| Topic number | LI88.85-P-061066 |
| Design group | 88.85 Trim strips |
| Validity | Model series 222 with code 413<br>As of VIN end no.: A073262<br>Up to VIN end no.: A134154 |

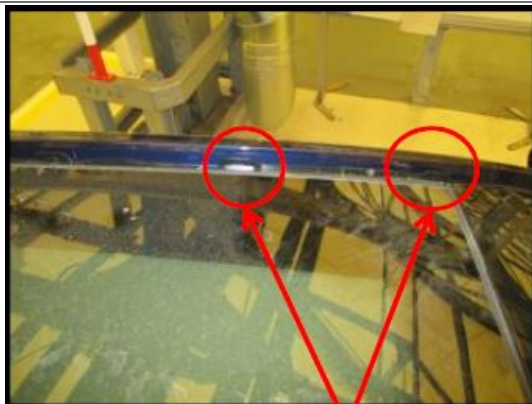
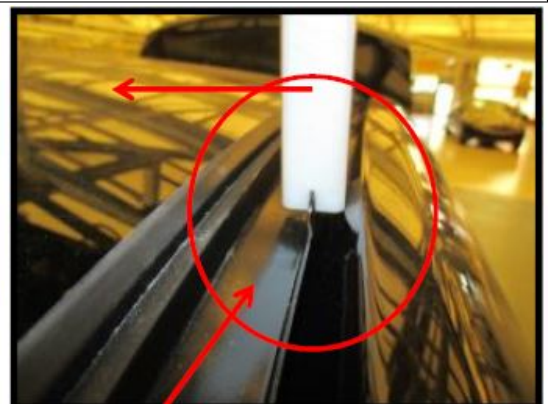
Bild 1.JPG:

Narrow opening at water deflector to panoramic roof.

Unevenly bonded side seal at panoramic roof.

Bend the mounting tabs of the front water deflector, see picture 1, by approx. 2-3 mm toward the vehicle interior.
