## Height adjustment of electric steering column adjustment inoperative

| Topic number | LI46.15-P-057157 |
| Design group | 46.15 Steering column adjustment |
| Validity | Model 231 up to vehicle ident. number<br>WDD231XXXXF20500<br>Model 463 with code XZ2 (modification year 2012) up to<br>VIN WDB463XXXXX213291 |

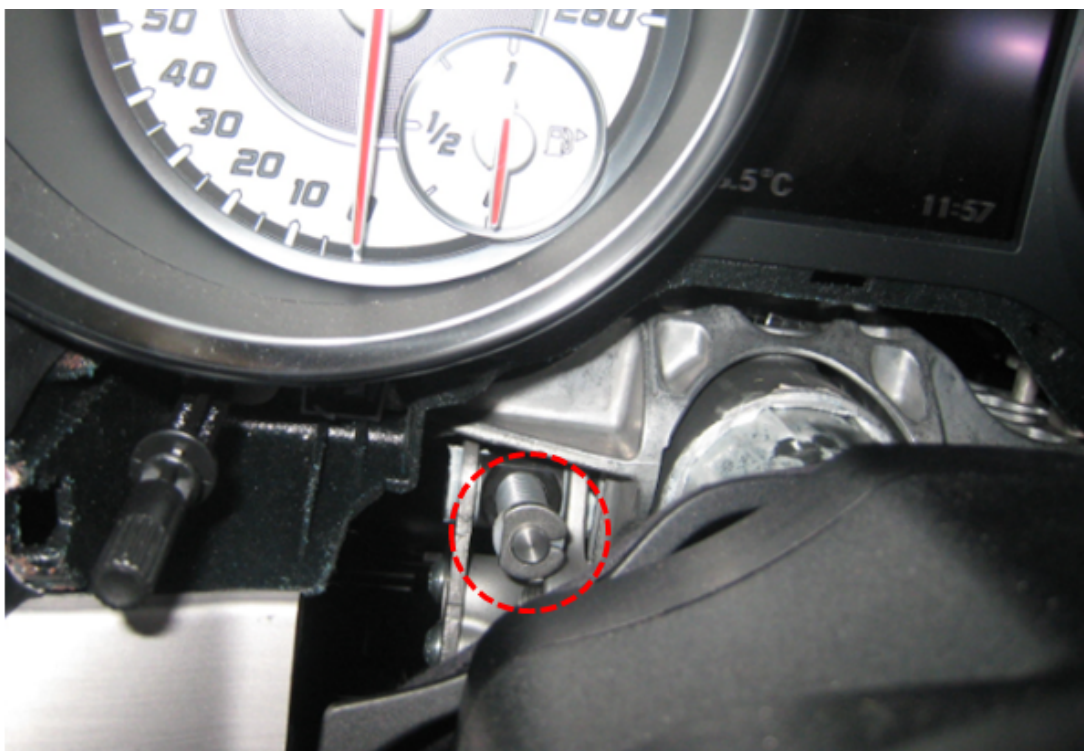
Bild 1.jpg:

Height adjustment moves to the top limit stop and jams.

| Attachments | |
|---|---|
| Bild 1.jpg | Installation location of height adjustment shaft |

- If the jamming can be released, proceed to 4.). If it is not possible to release the jamming, proceed to 3.)
- 3.) Detach the upper steering column trim and release the jamming by applying light hammer blows to the shaft of the height adjustment. When doing so, move the adjusting switch to the down position after each hammer blow. Repeat this procedure until the jamming is released. Use a suitable aid (hammer handle / round wooden bar) to strike the shaft.

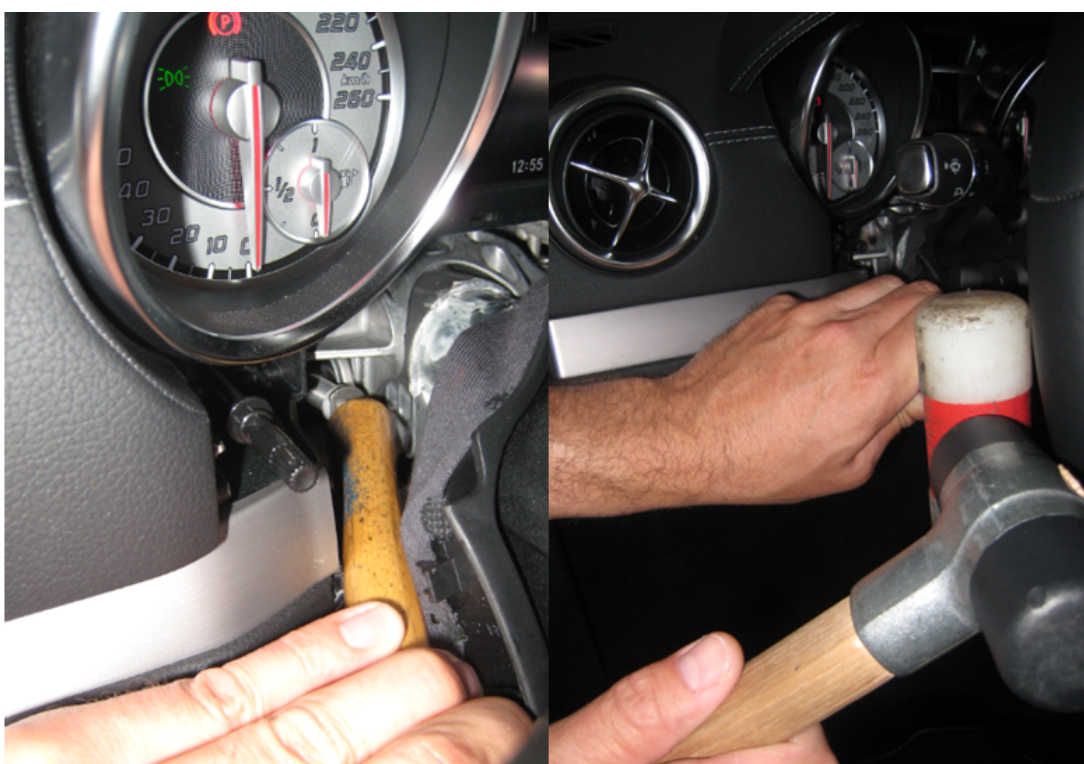
Bild 2.jpg:

| Attachments | |
|---|---|
| Bild 2.jpg | Tool positioning point on shaft for releasing jamming |
