## Residue on interior of headlamp assembly

| Topic number | LI82.10-P-061580 |
| Validity | Model series 212 |

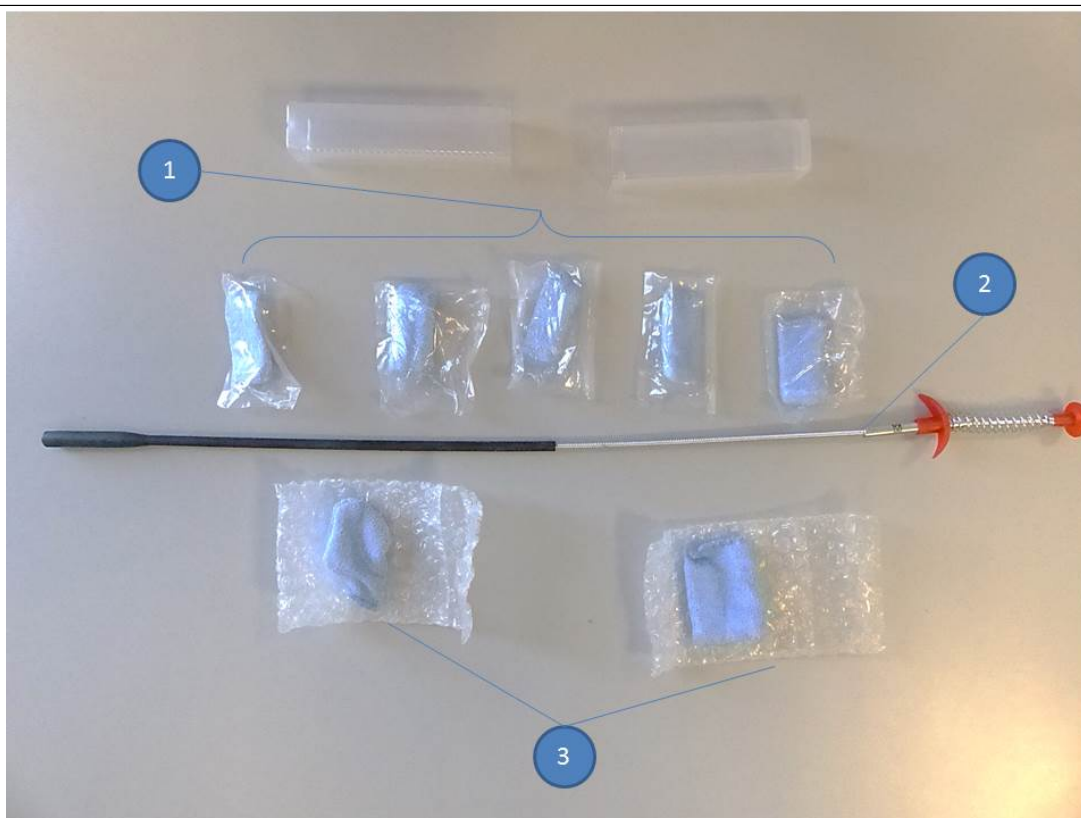
Rep. Kit.jpg:

| Attachments | |
|---|---|
| Rep. Kit.jpg | Repair kit:<br><br>1) Cleaning magnets inside<br><br>2) Pick-up tool isolated |

3) Guide magnet outside
