## Panoramic roof roller sun blind rubs on headliner and can be irreparably damaged

| Topic number | LI77.21-P-060553 |
| Design group | 77.21 Panoramic roof |
| Validity | Model series 217 up to VIN end no. 008167 |

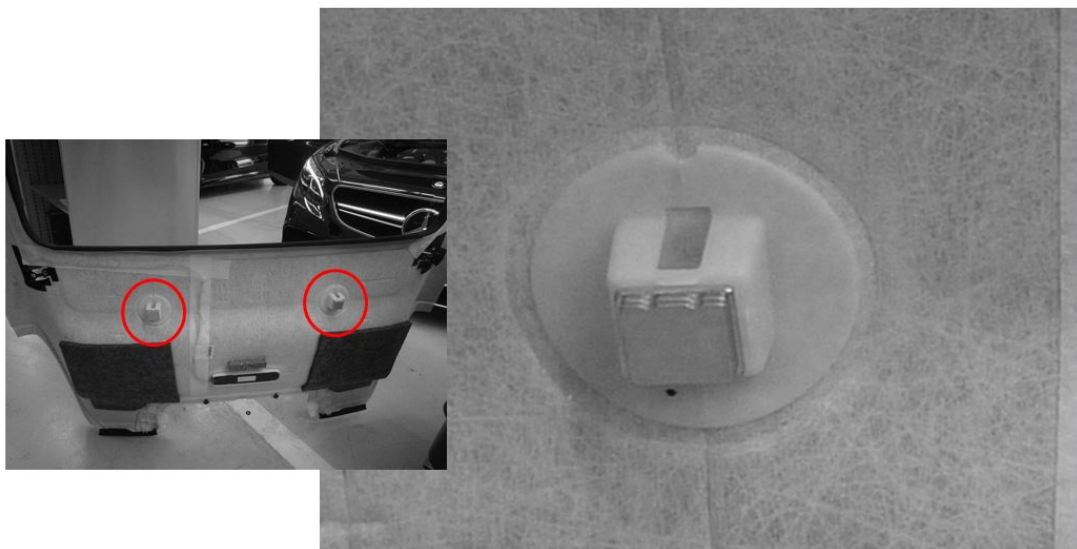
Bild 1.JPG:

1. Distance from roller blind shaft to headliner too short.
2. Gluing of fabric at edge fold of headliner not OK.
3. Cable routing in headliner not ideal.

- Remove headliner.
- Attach two additional retainers (magnetic) per side on the two domes, see Figure 1.
