## B-pillar trim in model series 117 chafed through

| Topic number | LI68.30-P-059216 |
| Design group | 68.30 Coverings, trim |
| Validity | Model series 117 up to VIN end number 204196 |

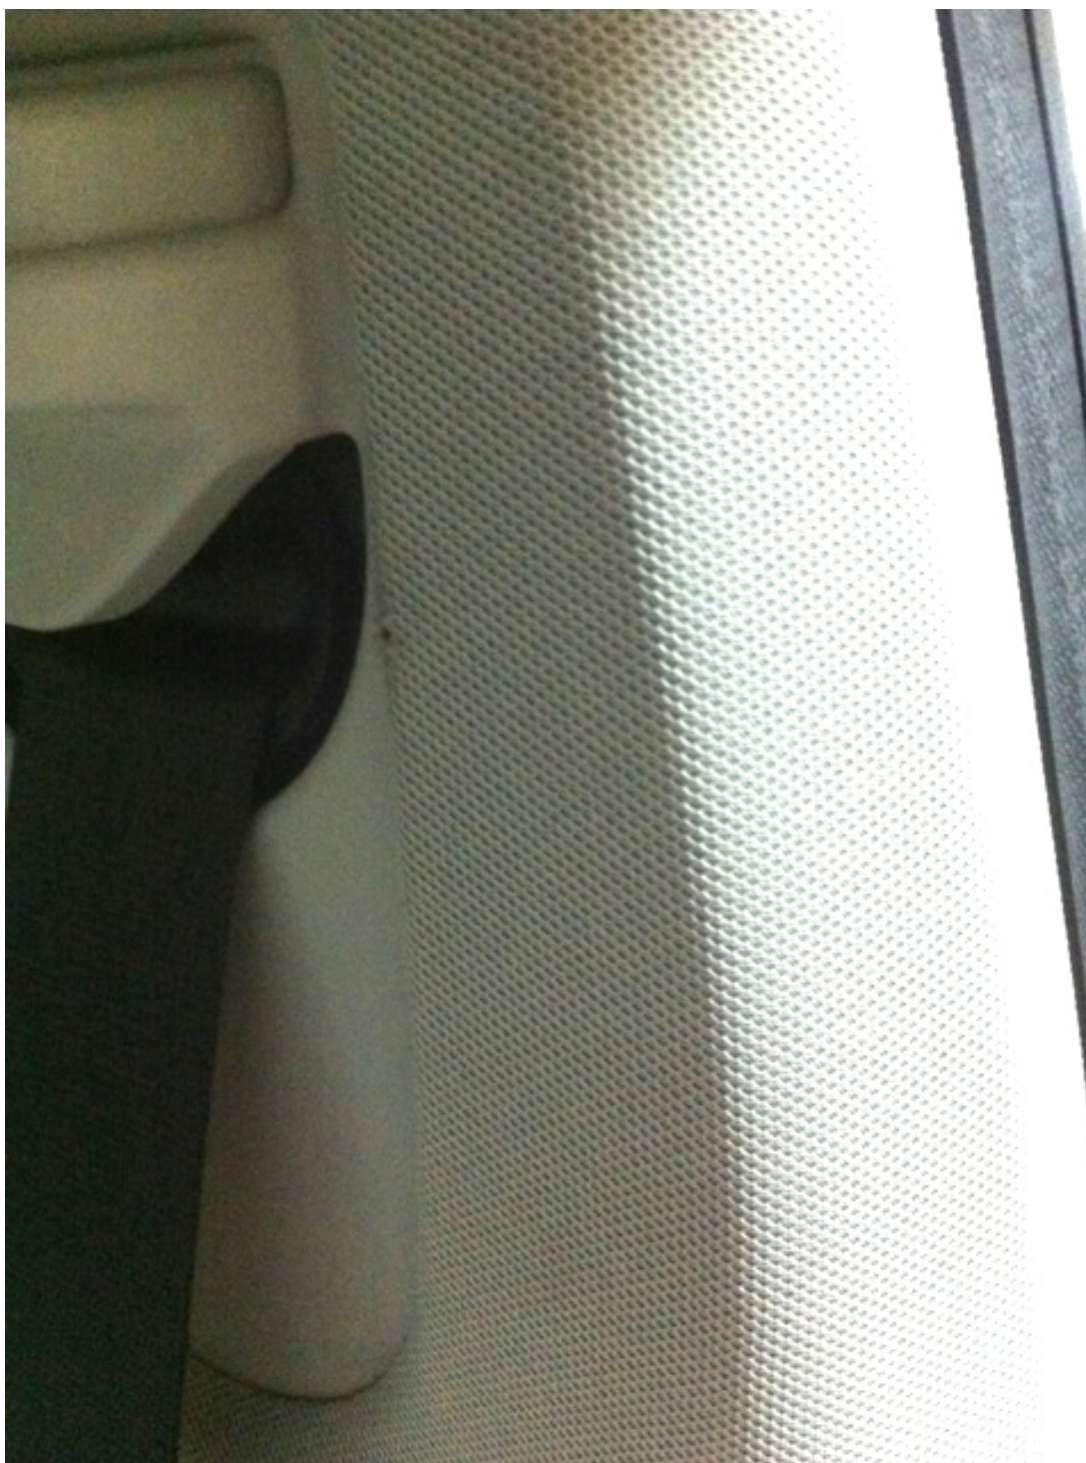
CLA 001.jpg:

The B-pillar trim in model series 117 is chafed through at the height of the belt outlet.

| Attachments | |
|---|---|
| CLA 001.jpg | Complaint |

Replacement of B-pillar trim with updated parts.

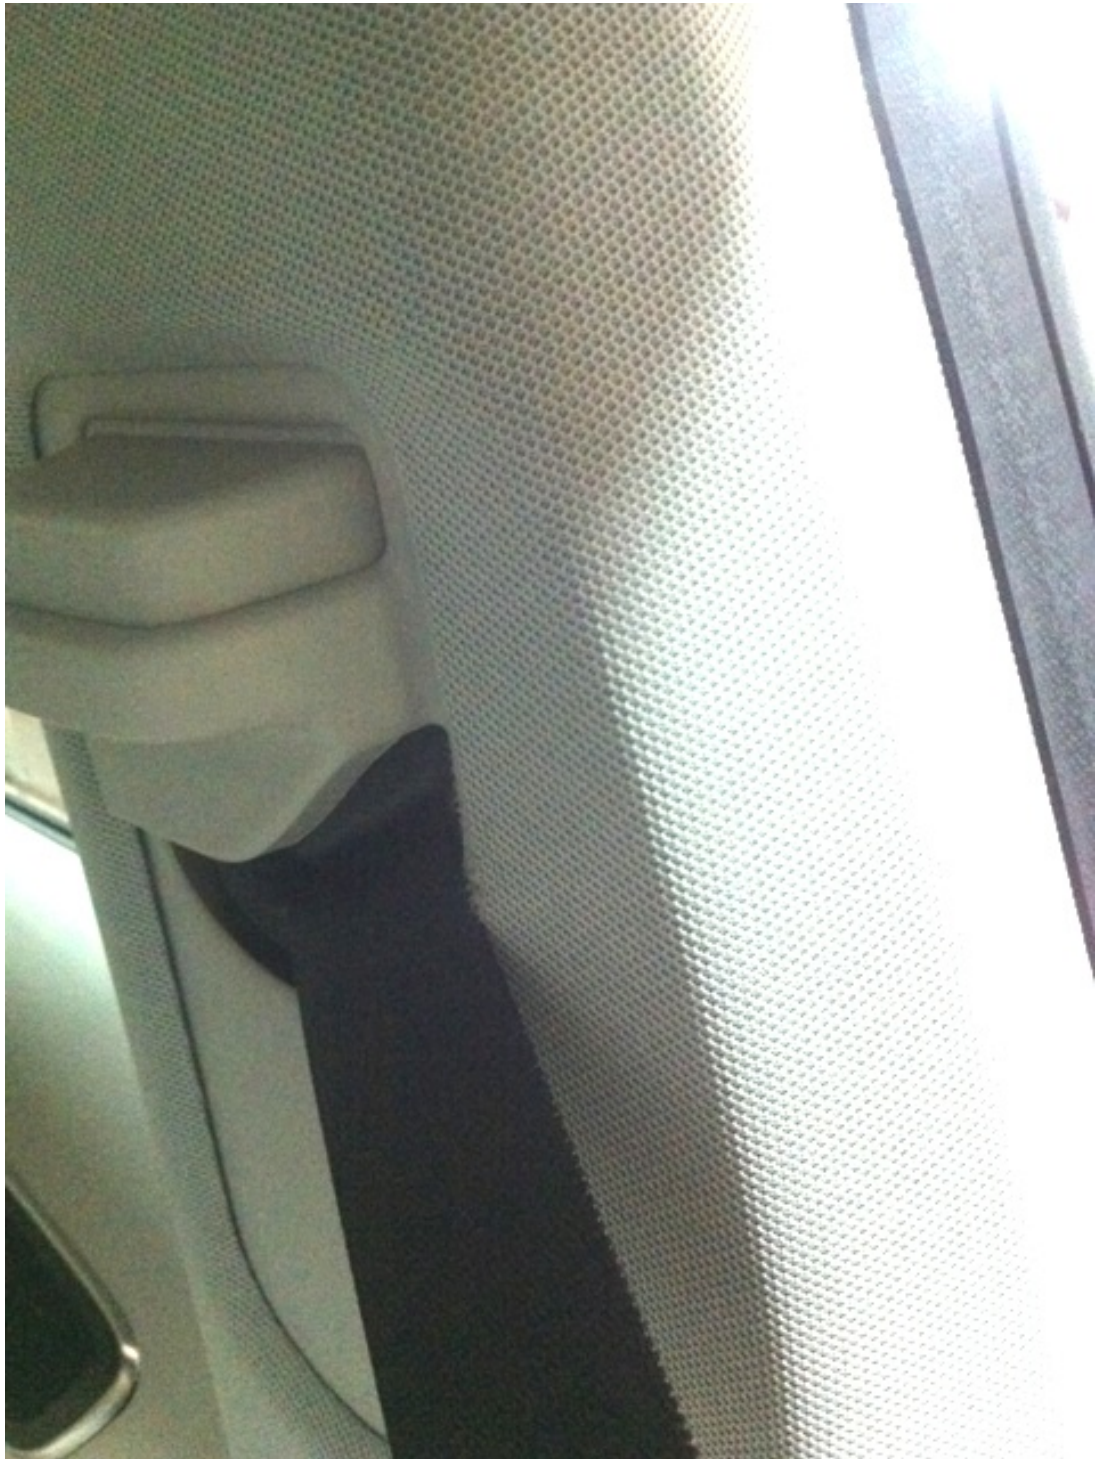
CLA 002.jpg:

| Attachments | |
|---|---|
| CLA 002.jpg | Complaint |

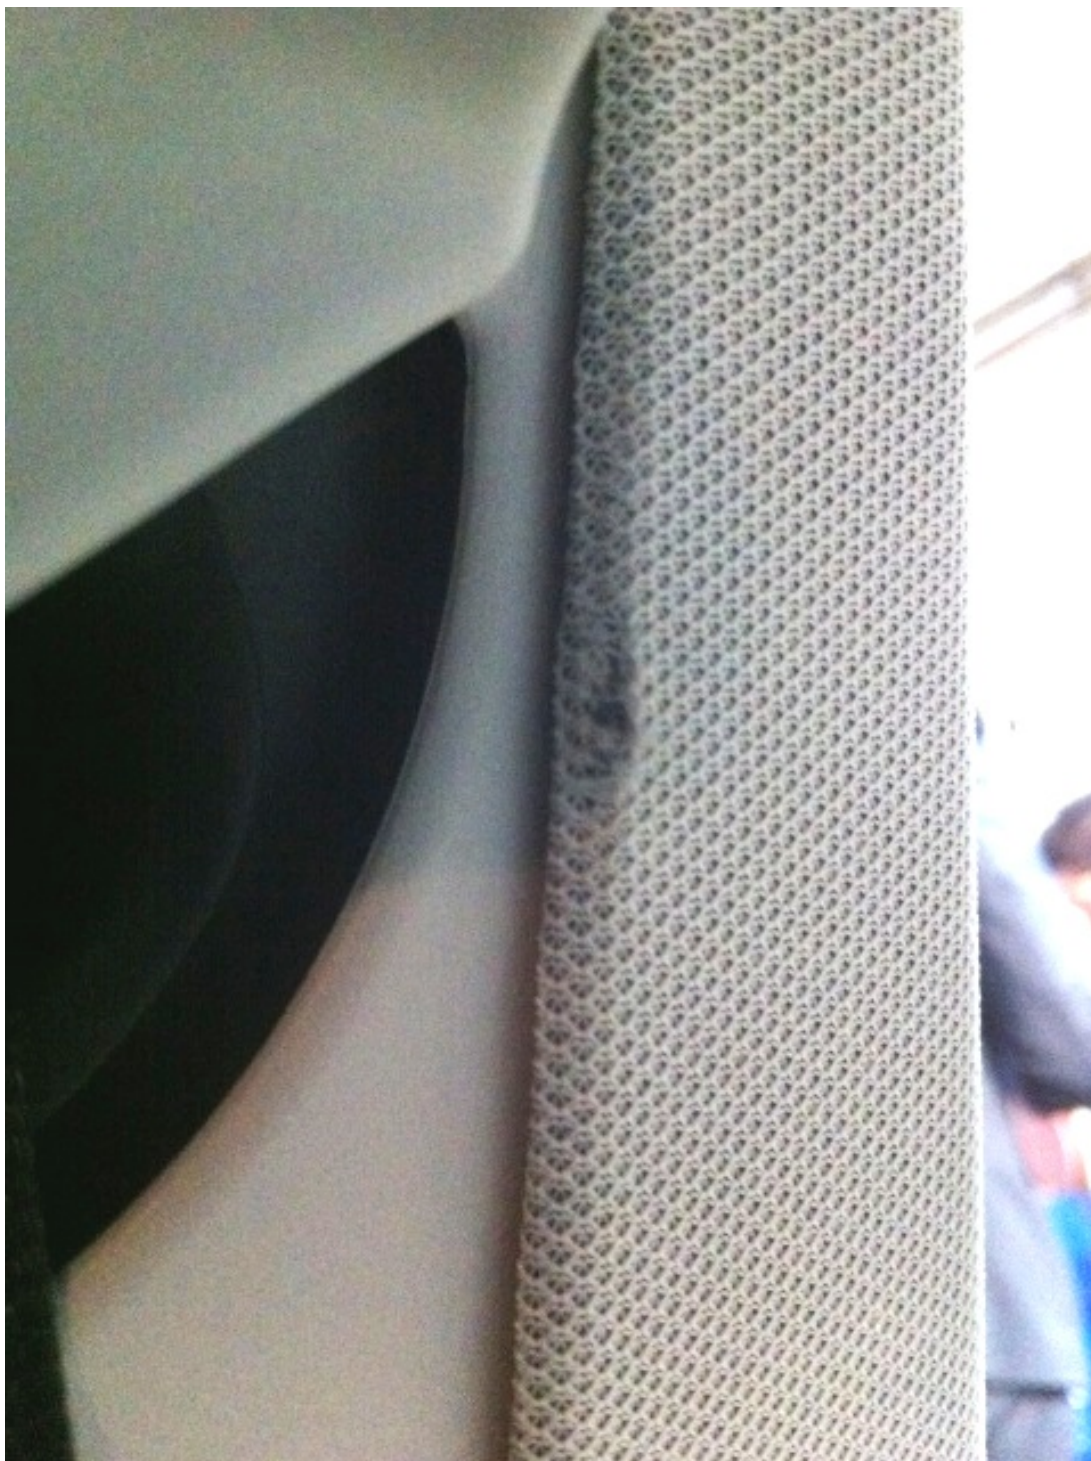
CLA 004.jpg:

| Attachments | |
|---|---|
| CLA 004.jpg | Complaint |

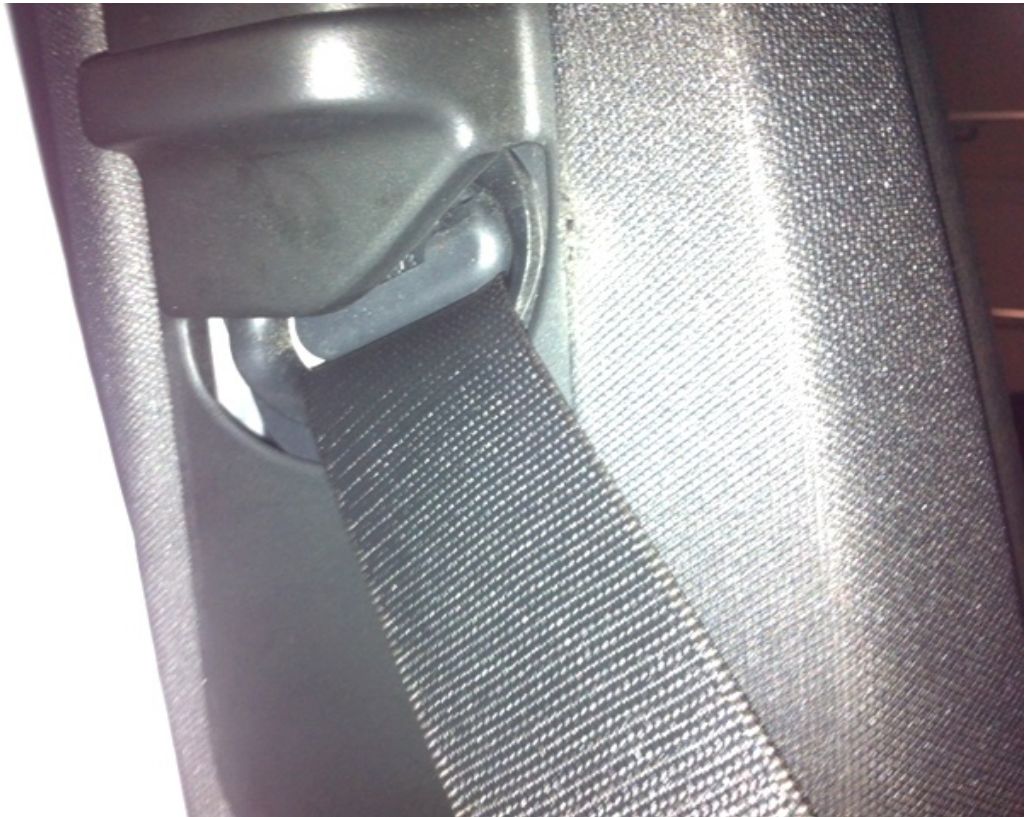
CLA 008.jpg:

| Attachments | |
|---|---|
| CLA 008.jpg | Complaint |

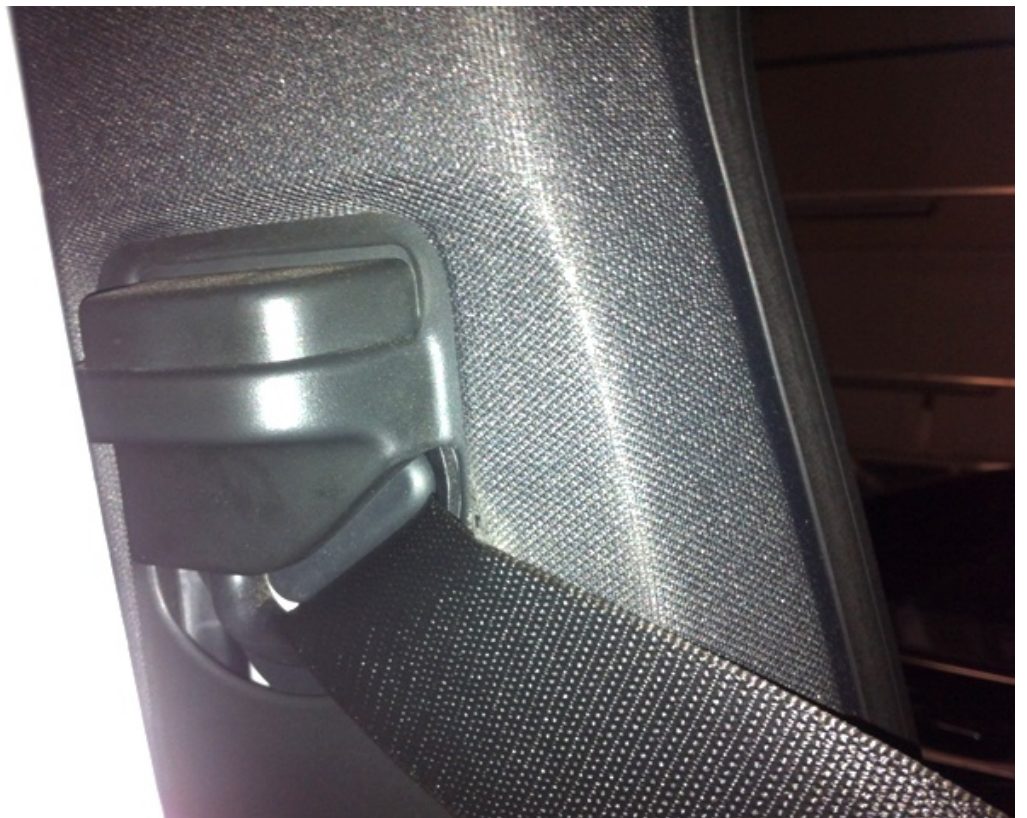
CLA 009.jpg:

| Attachments | |
|---|---|
| CLA 009.jpg | Complaint |
