SI B51 07 15
Body Equipment

Groaning Noise from Front Door Window Glass

F23 (2 Series Convertible)

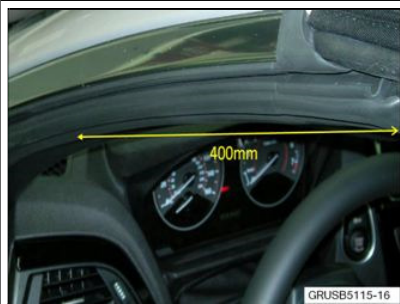
1. The driver's door is shown in the open position. Note: The area of concern is the first 400 mm from the top of the seal near the cowl. This noise can be generated by either the left or the right front window. It is recommended to lubricate both front seals to prevent the customer from returning to the workshop.

Open the door and clean the seal.
