Service Bulletin

Subject: Water Leak into Driver/Passenger Footwell or Within IP and/or Lower Dash Panel Insulators (Hush Panels)

Models: 2010-2012 Chevrolet Malibu

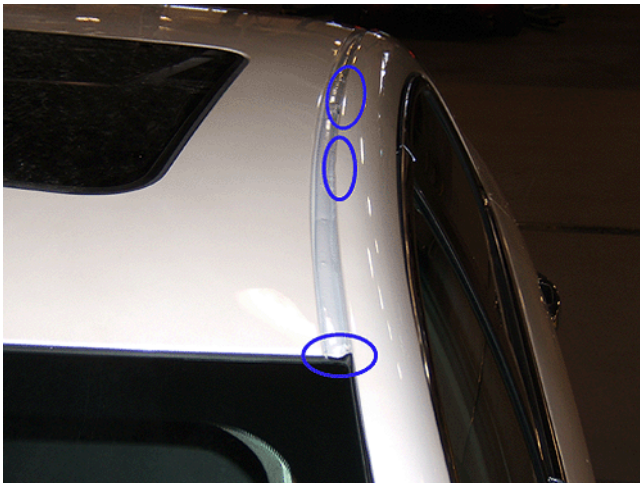
Some customers may comment on finding wet carpet in the driver or passenger footwell area. Upon further inspection, a technician may note water spotting or water accumulation within the IP structure and/or hush panel.

This condition may occur due to incomplete sealing within the roof to windshield header, A-pillar and/or B-pillar seams.

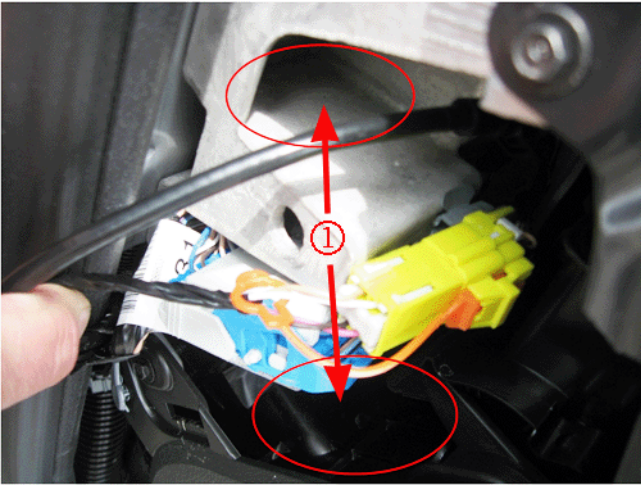
- Remove the IP outer trim cover and inspect for water/spotting within the end opening on the IP (1).

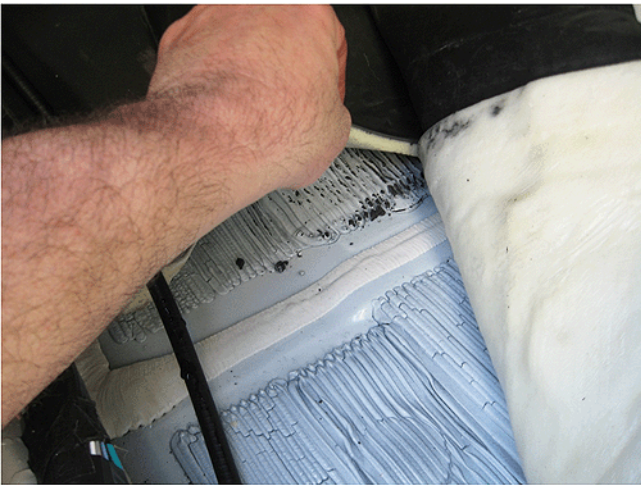
- Repositioning the front carpet, inspect for water/spotting between the carpet and the floorboard.

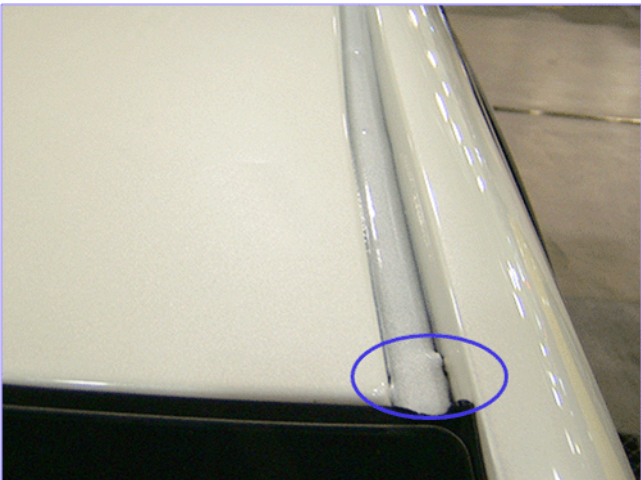
- At the windshield header and between the roof panel to A-pillar seam

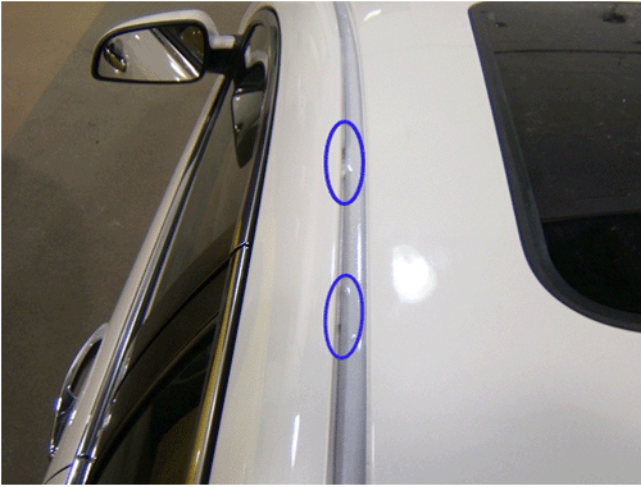
- Between the roof panel to B-pillar seam

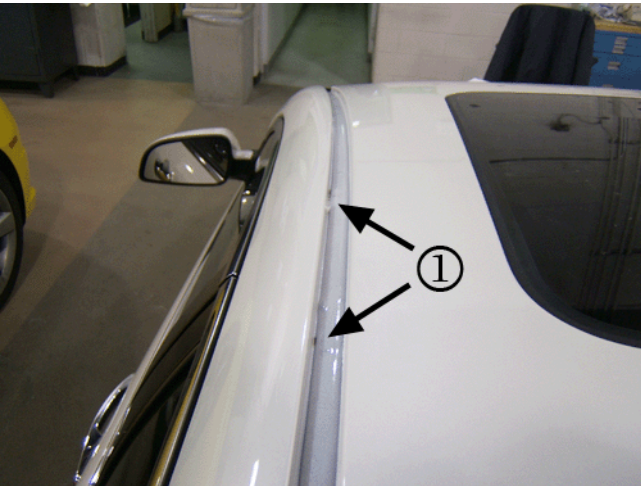
2. inspect for voids/gaps (1) in the seam sealer along the outboard edge of the roof ditch.
3. Seal all gaps with *Kent Automotive High-Tech™ Clear Seam Sealer, P/N 10200 (5 oz tube), or equivalent. Avoid excess sealer build up within the ditch while assuring any voids in the factory seal are filled.

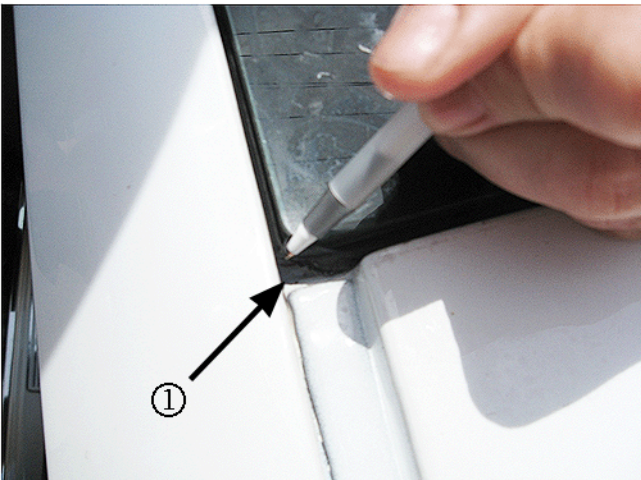
4. Also inspect the forward-most edge of the ditch, assuring any gaps in the factory sealer are filled. Inspect and seal all the way to and below the rubber windshield lace (1).
