Service Bulletin

Subject: Paint Chip on Right Rear Quarter Panel Due to Contact from Rear Compartment Lid

Brand:	Model:	Model Year:		VIN:		Engine:	Transmission:
		from	to	from	to		
Chevrolet	Camaro	2016	2016			All	All

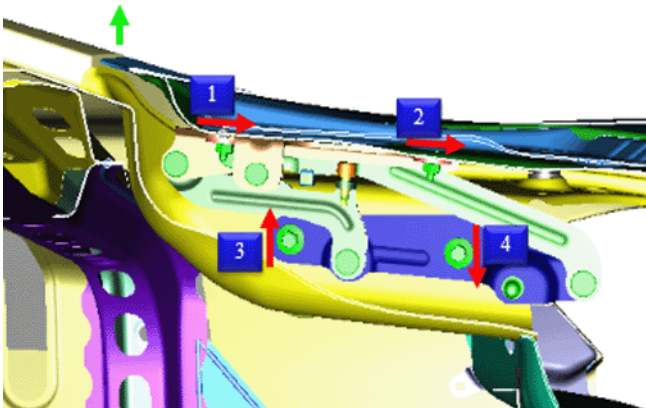
<p>Condition</p>	  <p>Some customers may comment on the paint being chipped on the quarter panel near the lower edge of the back glass.</p>
<p>Cause</p>	<p>This may be caused by an alignment issue of the rear compartment hinges, causing the rear compartment lid to contact the quarter panel during operation.</p>

1. Adjust the rear compartment lid by completing the following steps:

- 1.1. To adjust the compartment lid height, loosen both body side bolts (3 and 4) and take the forward one up and rearward one down.
- 1.2. To adjust the compartment lid gap, loosen the rear compartment lid side bolts (1 and 2) and pull the rear compartment lid aft.

- 1.3. Adjust the rear compartment lid in order to obtain an even gap between the rear compartment lid and the quarter outer panel, the rear tail lamp and the rear bumper fascia and so that the rear compartment lid is flush with the quarter outer panel, the rear tail lamp and the rear bumper fascia.

- Rear compartment lid to quarter outer panel (a) 3.0 mm ± 0.75 mm (0.12 in ± 0.03 in)
- Tail lamp to rear compartment lid (b) 6.25 mm ± 1.5 mm (0.25 in ± 0.06 in)
- Rear compartment lid to rear bumper fascia (c) 6.0 mm ± 1.5 mm (0.24 in ± 0.06 in)

- 9 Y (80 lb in)
