Service Bulletin

PRELIMINARY INFORMATION

Subject: Diagnostic Tips for Reduced Acceleration at Low Speed and/or Transmission Slipping from a Launch, DTC P0751 Set

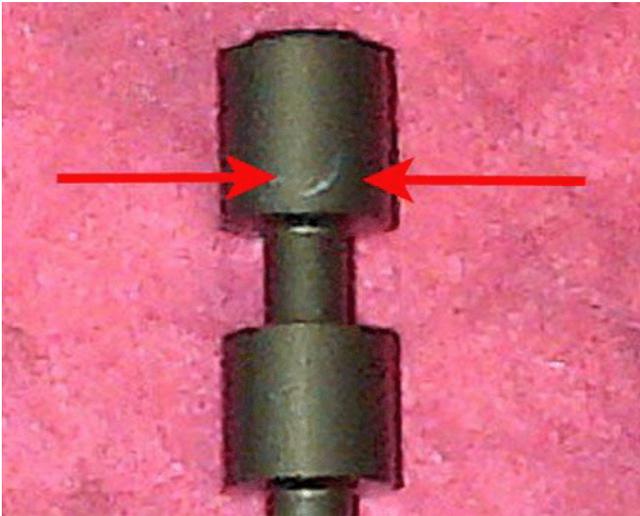
The recommended inspection procedure is to remove the valve and inspect it for any scratches on the valves. The illustration above shows an example of a valve with a scratch mark on it. If the valve is stuck in the bore or shows signs of scratching or damage, the lower valve body should be replaced.
