# Service Bulletin

**Subject:** Engineering Information – Vehicle Pulls to One Side and/or Steering Feels Loose

**Models:** 2015-2016 Chevrolet Colorado  
2015-2016 GMC Canyon

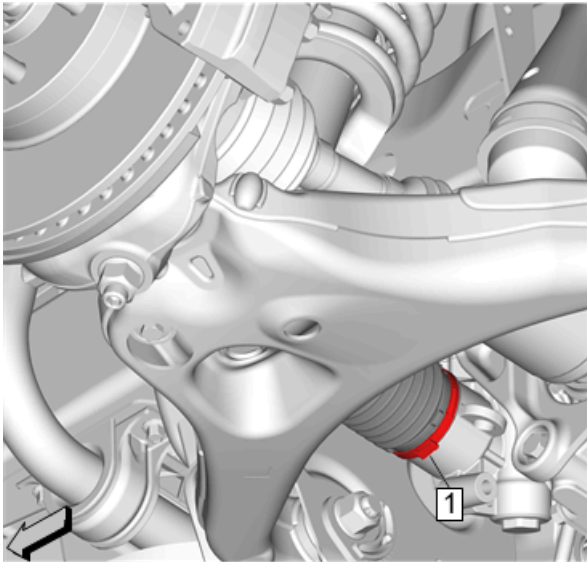
2. With the vehicle in full rebound and the wheel straight, remove the inner steering gear boot clamp (1). Refer to Steering Gear Boot Replacement in SI.

3. With the boot pulled outward from the vehicle, visually inspect the following:

- Which side of the vehicle is the inner tie rod loose on?
- Is the tie rod making contact to the rim of the tie rod ball housing while turning the wheel fully to the left or the right ?
