Service Bulletin

Subject: Left Front Tweeter Speaker Inoperative or Produces Static

Brand:	Model:	Model Year:		Breakpoint:		Engine:	Transmission:
		from	to	from	to		
Chevrolet	Colorado	2015	2016	May 1, 2015	July 1, 2015	All	All
GMC	Canyon	2015	2016			All	All

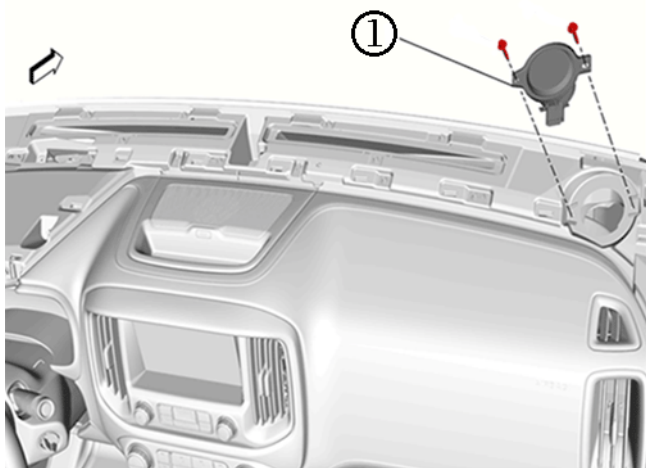
Condition	Some customers may comment that the left front tweeter speaker is inoperative or produces static.
Cause	The cause of the condition may be poor terminal tension at the speaker connector or a terminal backed out of the connector.
Additional Options	Equipped with SPEAKER SYSTEM – ENHANCED AUDIO (RPO UQ3)

Note: The right tweeter speaker (1) is shown in the graphic above. The left speaker is similar.

First refer to # PIT5462 to eliminate the possibility of a pinched/mis-routed harness causing the condition. If the harness is not found to be the cause, replace the left front tweeter speaker connector kit using the service part listed in the Parts Information below.

1. Remove the left tweeter speaker and disconnect the electrical connector. Refer to Radio Front Speaker Replacement in SI.
2. Replace the tweeter speaker pigtail connector. Refer to Connector Repairs in SI.
3. Reconnect the speaker electrical connector and verify proper operation on the speaker.
4. Reinstall the speaker. Refer to Radio Front Speaker Replacement in SI.
