# Service Bulletin

**Subject:** GM of Canada OnStar® Cellular Communication Upgrade

**Models:** 2000-2014 GM Passenger Cars and Light Duty Trucks  
2015 Buick Enclave  
2015 Cadillac Escalade Models (Built W/O VV4)  
2015 Chevrolet Camaro, Express, Traverse  
2015 Chevrolet Silverado 2500/3500, Suburban, Tahoe (Built W/O VV4)  
2012 Chevrolet Colorado  
2015 GMC Acadia, Savana  
2015 GMC Sierra 2500/3500, Yukon Models (Built W/O VV4)  
2012 GMC Canyon  
2005-2010 Pontiac Vibe  
Equipped with OnStar® (RPO UE1)

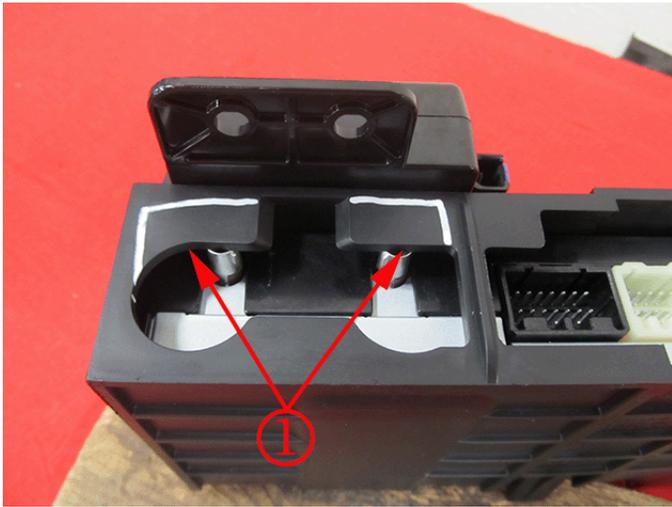
#### **Buick Encore (2013-2014) / Chevrolet Trax (2013-2014)**

Follow the appropriate instructions if this condition exists:

Remove the illustrated sections (1) of the bracket to allow the module's connectors access.

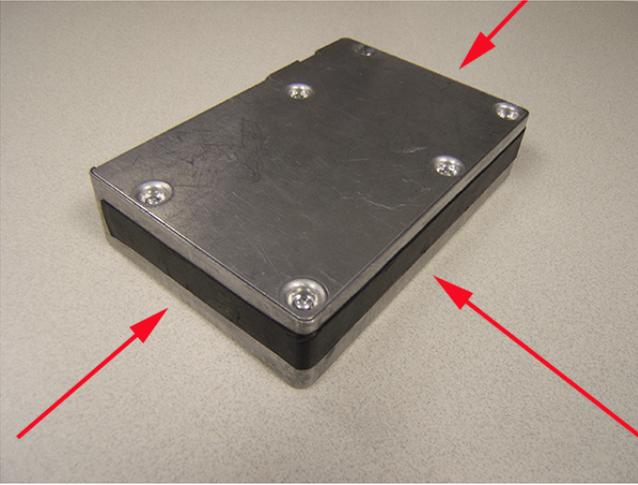
**Note:** Wrapping the module with rubber tape will help prevent movement in the bracket after installed.

Wrap the new module with Scotch™ Linerless Rubber Splicing Tape 130C, 19 mm (3/4 in) wide, (rubber tape) or equivalent from left to right, covering the back side of the module as illustrated.
