Service Bulletin

Subject: Poor Radio Hands-free Voice Recognition Performance or Sound Quality After OnStar Upgrade

Models: 2008-2015 Buick Enclave
 2012 Buick Verano
 2006-2011 Cadillac DTS
 2007-2009 Cadillac SRX
 2007-2013 Cadillac Escalade
 2008-2015 Cadillac CTS
 2007-2013 Chevrolet Avalanche, Silverado, Suburban, Tahoe
 2007-2013 GMC Denali, Sierra, Yukon
 2007-2015 GMC Acadia
 2007-2010 Saturn OUTLOOK

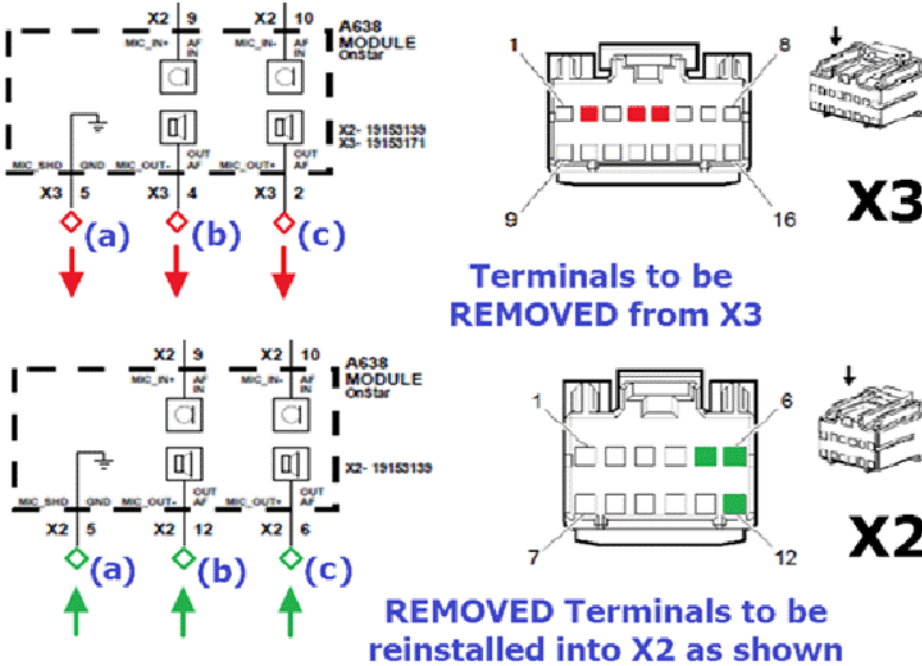
Repair 1 - OnStar Module, Relocate the Microphone and Ground Circuits from X3 to X2 Connector

After the GM of Canada OnStar Cellular Communication Upgrade (Bulletin 15-08-44-001 or later), some vehicles with radio hands-free voice recognition are at risk of experiencing performance and sound quality issues such as:

- a: Move terminal 5 on X3 to terminal 5 on X2.
- b: Move terminal 4 on X3 to terminal 12 on X2.
- c: Move terminal 2 on X3 to terminal 6 on X2.

- (a) Move terminal 5 on X3 to terminal 5 on X2
- (b) Move terminal 4 on X3 to terminal 12 on X2
- (c) Move terminal 2 on X3 to terminal 6 on X2
