Service Bulletin

Subject: Unable to Manually Unlock the Driver Door Using Key from the FOB

Models: 2015 Cadillac ATS Coupe
Export RPO - UTT, Built Prior to December 5, 2014

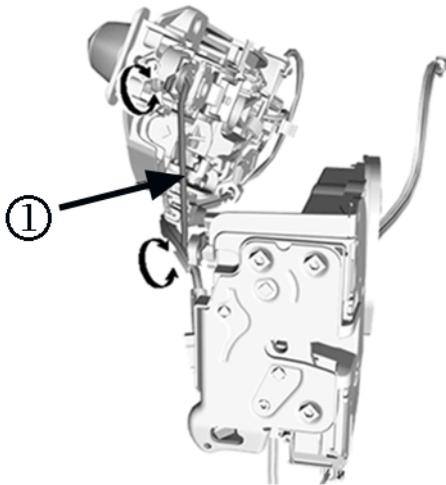
The cause of this condition may be that the driver door may have been built using the incorrect lock rod. This incorrect lock rod will not allow the door to manually unlock using the key.

1. Remove the driver door lock rod (1). Refer to Front Side Door Lock Cylinder Rod Replacement (Coupe) in SI.
2. Install the new lock rod. Refer to Front Side Door lock cylinder Rod Replacement (Coupe) in SI.
