Service Bulletin

PRELIMINARY INFORMATION

Subject: Intermittent Gauges Drop and/or Radio and HVAC Displays Blank Out When Passenger Seat is Occupied

Models: 2013-2014 Chevrolet Malibu
Built Prior to March 14, 2014

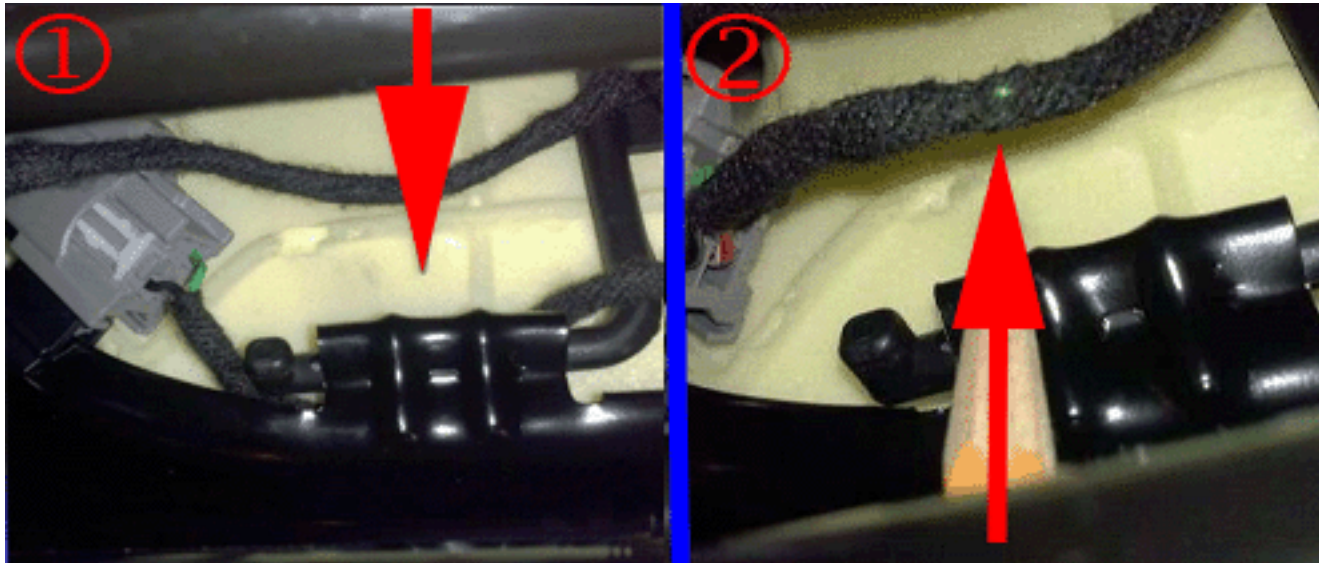
This may be caused by a chaffed wire or short to ground in circuit 5060 from X320 cavity 7 to the Passenger Presence Sensor.

1. Before Harness Removed from Seat Frame

2. After Harness Removed from Seat Frame

2. With the seat removed, visually inspect the passenger presence sensor harness for chaffing or exposed bare copper wire.

3. If there is chaffing or exposed copper wire, repair the damaged wire insulation. Refer to Repairing Damaged Wire Insulation in SI.
