Service Bulletin

PRELIMINARY INFORMATION

Subject: Wax Coating on Frame Peeling, Metal Shows Corrosion/Rusting (U.S. and Canada Only)

Models: 2011-2015 Cadillac Escalade Models
2011-2013 Chevrolet Avalanche
2011-2015 Chevrolet Express, Silverado, Suburban, Tahoe
2011-2015 GMC Savana, Sierra Models, Yukon Models

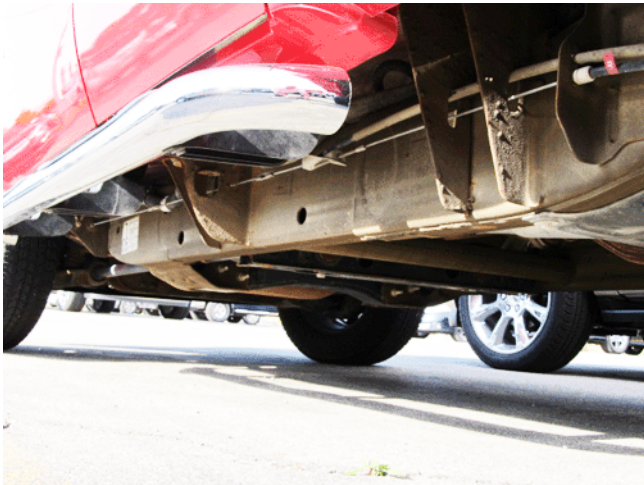
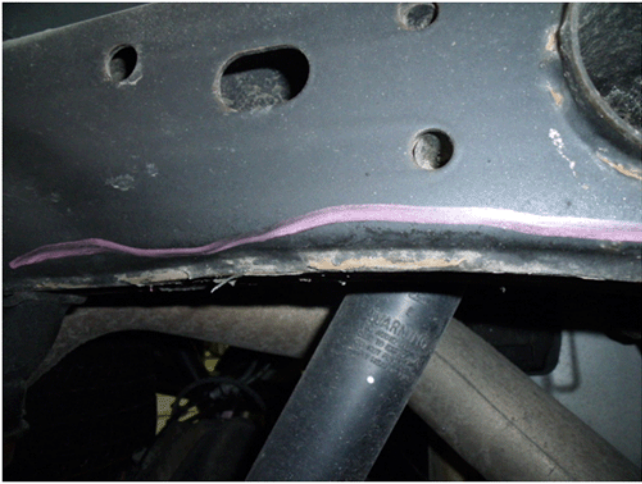
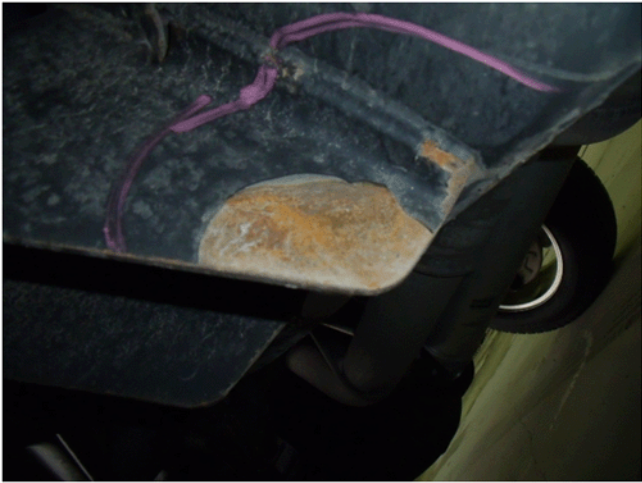
Truck Example Photos

Some customers may comment that areas of the frame wax coating are peeling off and rust/corrosion is visible on the metal in these areas. Several examples of this condition are shown in each group of graphics below.

A combination of specialized metal coating products manufactured by Lloyds and Daubert have been found to be the most suitable products to provide corrosion control and protection to address this type of repair. Our recommendation is to prep the metal surface using *Lloyd's Pure Prep™ Metal Surface Preparation P/N 25418, then topcoat with both *Lloyds Kryptonite Metal Treatment P/N 36502 Life Long Rust Protection and *Daubert Non-Rust® P/N X-121B One Coat Rust Preventative Coating. It is strongly recommended they be applied according to the manufacturer's procedures.
