Service Bulletin

Subject: Wind Noise and/or Water Leak at Front Roof or Windshield, Water Running Down Interior A-Pillar

Models: 2013-2015 Cadillac ATS

2014-2015 Cadillac CTS

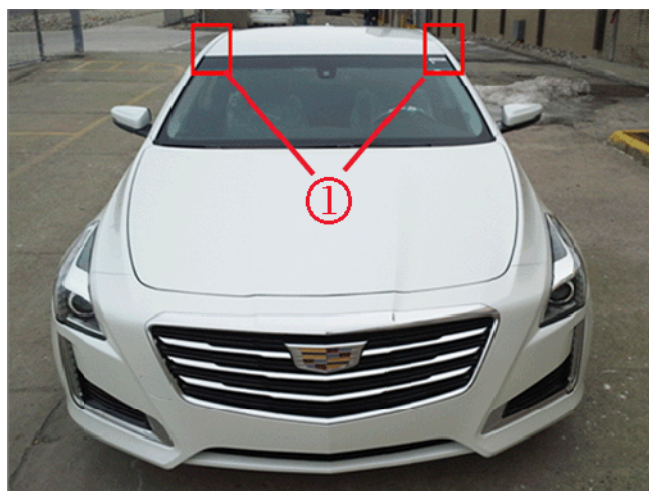
The cause of this condition may be pin holes, cracks or voids in the forward roof ditch laser braze area, or in the upper windshield flange seam or lower corners of the windshield opening. Examples of the leak areas are shown below.

Possible Laser Braze Water Leak Areas (1)

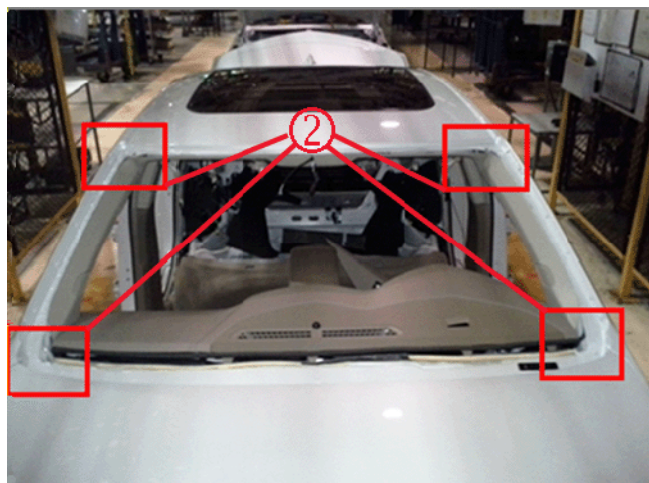
Possible Windshield Opening Flange Seam Water Leak Areas (2)

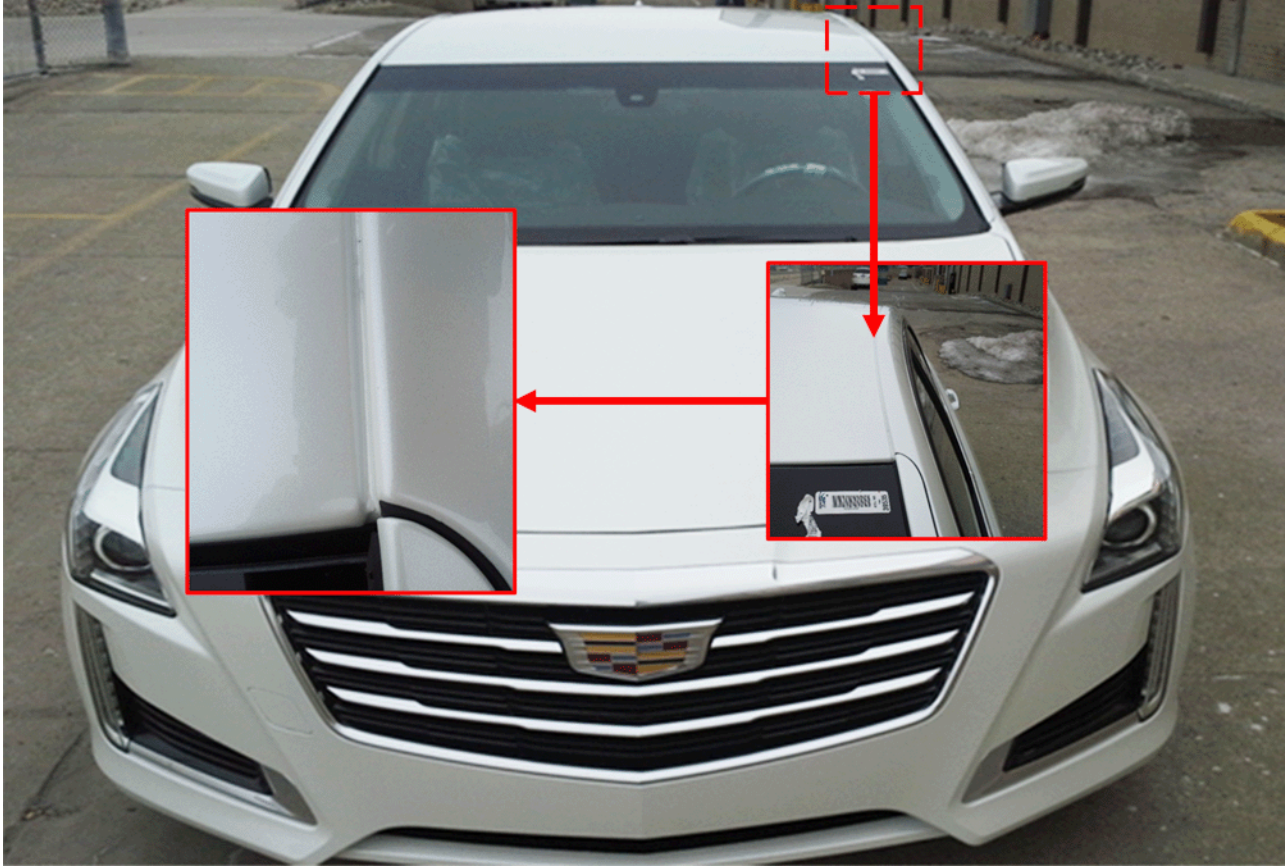
Inspect the forward laser braze and water test the roof ditch and upper windshield area on the affected side(s).

1. Ensure the front laser braze area, shown in the graphic above, is clean and dry. Left side is shown, right side is similar.

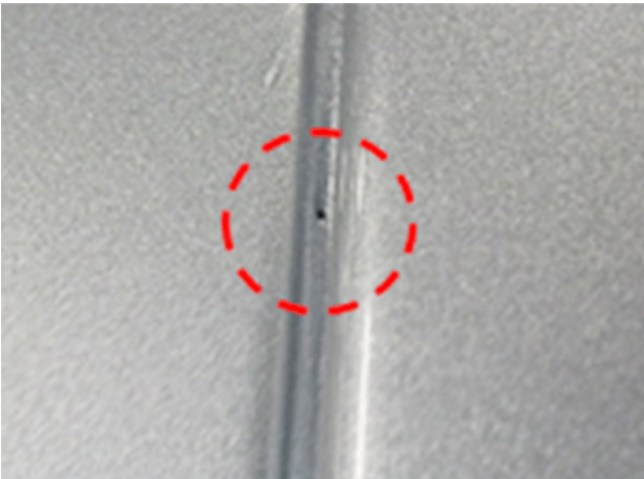
Note: The pin holes/cracks may be more difficult to see on darker color finishes. An example of a visible pin hole is shown in the graphic above.

5. If water leak is verified, visually inspect the roof laser braze for pin holes or a crack.
 - If NO holes/cracks are evident, move ahead to step # 8 and perform the windshield resealing.
 - If any holes/cracks are evident, continue ahead to step # 6.
6. Seal the holes/crack in the laser braze following the steps below:
 - 6.1. Mix a small amount of *Kent Automotive High-Tech Clear Seam Sealer, P/N 10200 (5 oz tube), or equivalent, WITH the proper touch up paint color.

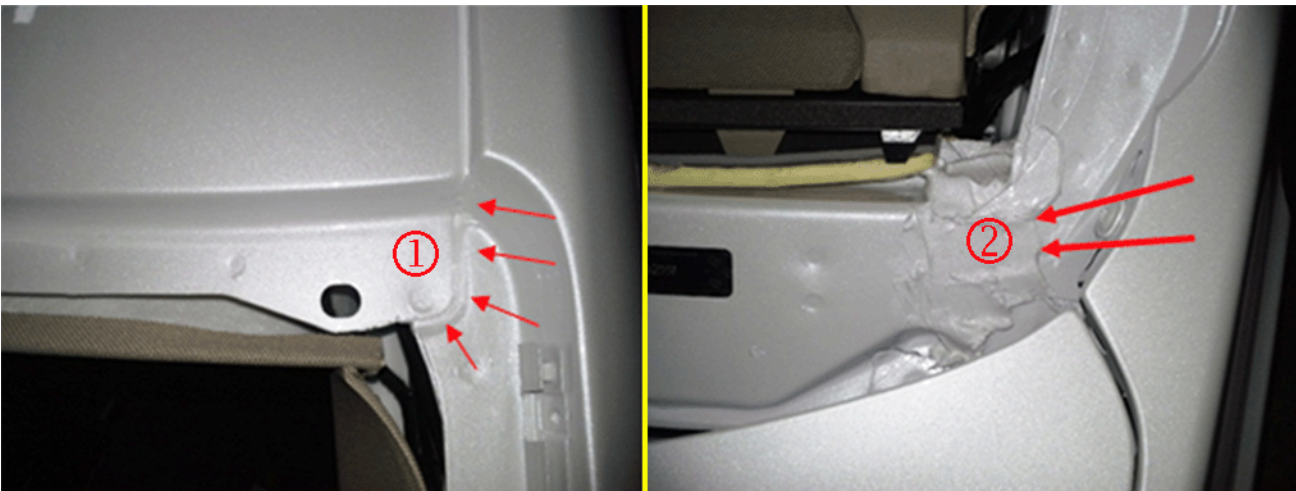
Note: The examples above are showing the left side, but condition could be on either side.

9. On the affected side(s), inspect the upper windshield flange seam (at the end of the laser braze) (1) and the lower corner flange seam (2) for any visual signs of pin holes, voids or skips. Reseal any seams, as necessary.
