Service Bulletin

Subject: Top Not Secure Message Displayed in Driver Information Center (DIC)

Models: 2011-2015 Chevrolet Camaro Convertible

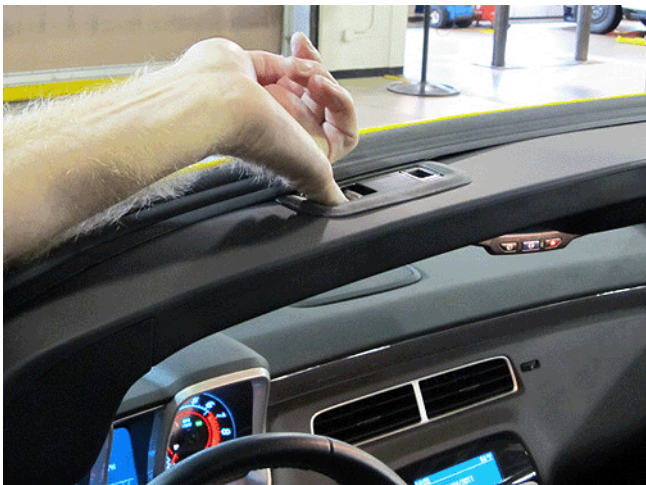
1. With the top partially open and the ignition key in the on position, you will see a "Top Not Secure" message displayed in the DIC.

2. Using your little finger (as shown in the graphic above), reach in the driver's side latch striker and toggle the micro switch while observing the DIC. The "Top Not Secure" message should also toggle off and on.

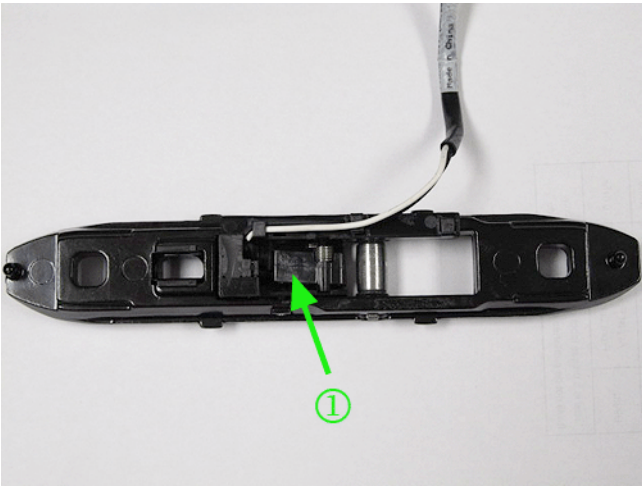
Note: For clarification purposes, the graphic below shows the striker removed for an underside view of the toggle switch (1).

3. If the message toggles back and forth, the latch and switch are operating properly, so it will be necessary to complete the adjustment procedure below.

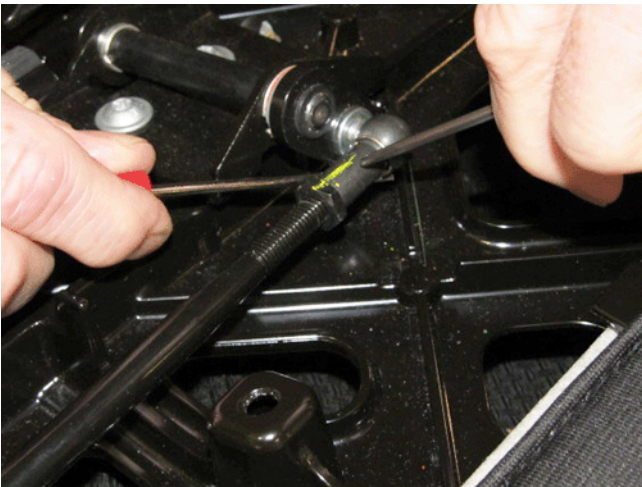
Note: When removing the link rod from the latch, you must remove the locking retainer (1), make the rod adjustment, then be sure to reinstall the retainer.

Tip: To remove the retainer, rotate it to unsnap it from the rod, then slide it off. To disengage the socket, the retainer has to be fully removed.

3. Remove the locking retainer from the ball socket and disengage the socket from the latch stud.

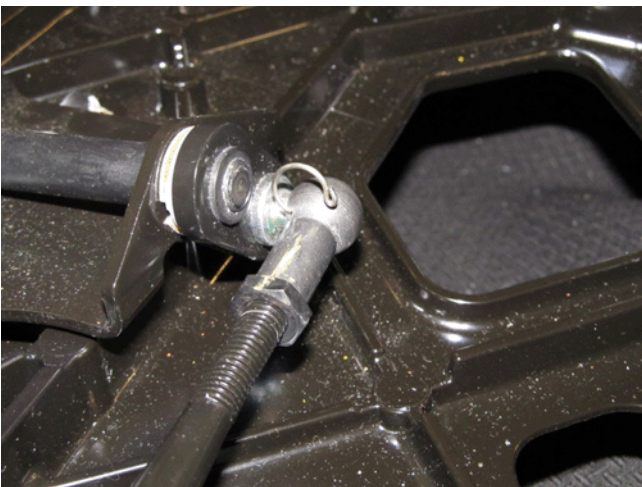
Note: The above graphic shows the locking retainer in intermittent position for illustration purposes only. When fully installed, the retainer is rotated and snapped tightly around the link rod.

4. Adjust the driver's side top latch by extending the link rod ball socket one complete turn. This will move the top latch inward to allow better contact with the striker micro switch. Re-tighten the jamb nut.

5. Re-engage the ball socket to the latch and reinstall the locking retainer.
6. Reinstall the folding top #1 bow garnish molding. Refer to Folding Top Number 1 Bow Garnish Molding Replacement in SI.
