# Service Bulletin

**Subject:** Engineering Information – Vehicle Pulls to One Side and/or Steering Feels Loose

**Models:** 2015 Chevrolet Colorado  
2015 GMC Canyon

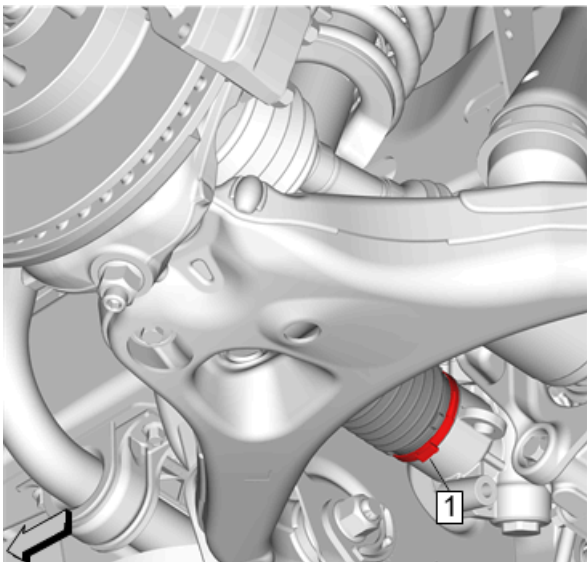
1. With the vehicle in full rebound and the wheel straight, remove the inner steering gear boot clamp (1). Refer to Steering Gear Boot Replacement in SI.  
**Note:** The inner steering gear boot clamp will need to be replaced once removed.
2. With the boot pulled outward from the vehicle, visually inspect the following:
  - Which side of the vehicle is the inner tie rod loose on?
  - Is the tie rod making contact to the rim of the tie rod ball housing while turning the wheel fully to the left or the right ?
