Service Bulletin

Subject: Information for Identifying Non-GM ECM Calibration Use and Power-Up Hardware Detection in Duramax™ Diesel Engines — Photograph Tech 2® Calibration IDs, Calibration Verification Numbers (CVNs) and Transmission Data Screen

Models: 2006-2013 Chevrolet Express, Kodiak, Silverado
2006-2013 GMC Savana, Sierra, TopKick
Equipped With Duramax™ Turbocharged Diesel Engine RPO LB7, LBZ, LLY, LML, LMM, or LGH

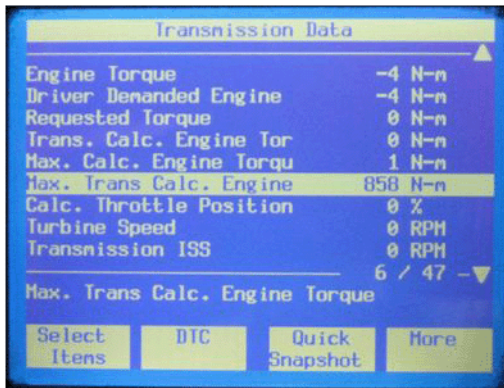
Transmission Data Screen (Max. Transmission Calc. Engine Torque Parameter)

A transmission control module (TCM) algorithm has been implemented that records a maximum calculated input torque. This information is available via the Tech 2®.

6. Take a clear digital picture in the .jpg file format of the Tech 2® screen showing the Transmission Data and the Max. Transmission Calc. Engine Torque parameter.
7. Retain the Tech 2® Transmission Data screen photograph with the repair order.
