Service Bulletin

PRELIMINARY INFORMATION

Subject: Front Seat Lateral Movement, Clunk, Squeak, Click Noise or Shift While Cornering

Models: 2012-2015 Buick Regal
2012-2015 Buick Verano
2011-2015 Chevrolet Cruze
2013-2015 Chevrolet Malibu
2014-2015 Chevrolet Impala (VIN 1)
2014-2015 Chevrolet SS

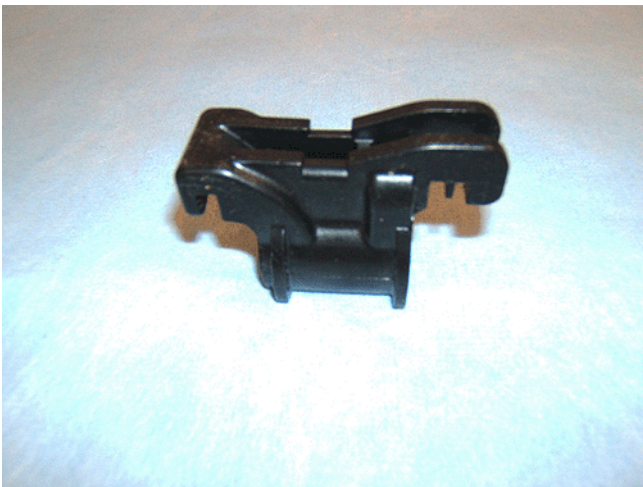
Some customers may comment on a lateral movement in the seat while cornering. This condition has also been described as a clunk, squeak, click noise or shift in the seat. This condition occurs on the driver side 6-way manual or power adjusted seat. This condition may also be present on the passenger side seat if the vehicle is equipped with a 6-way adjustable passenger seat.

This condition may be caused by movement between the seat pan and the seat cross tube.

A clip has been made available to eliminate the lateral seat movement. Use the following steps to install the clip to the driver side seat. If the vehicle is equipped with a 6-way adjustable passenger seat, repeat the procedure on the passenger seat.

1. Raise the front of the seat bottom to the highest position and move the seat assembly to the rearmost position.
