# Service Bulletin

**Subject:** Information for No Trouble Found Turbochargers Returned to Warranty Parts Center

**Models:** 2013-2015 Buick Encore  
2011-2015 Chevrolet Cruze  
2012-2015 Chevrolet Sonic  
2014 Chevrolet Trax (Canada)  
2015 Chevrolet Trax (U.S. and Canada)  
Equipped with Engine RPO LUJ or LUV

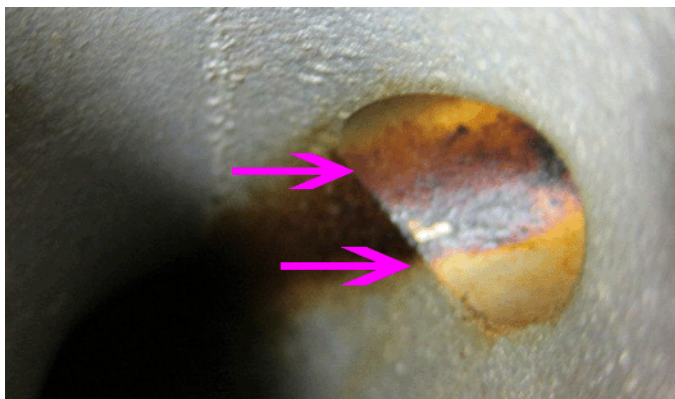
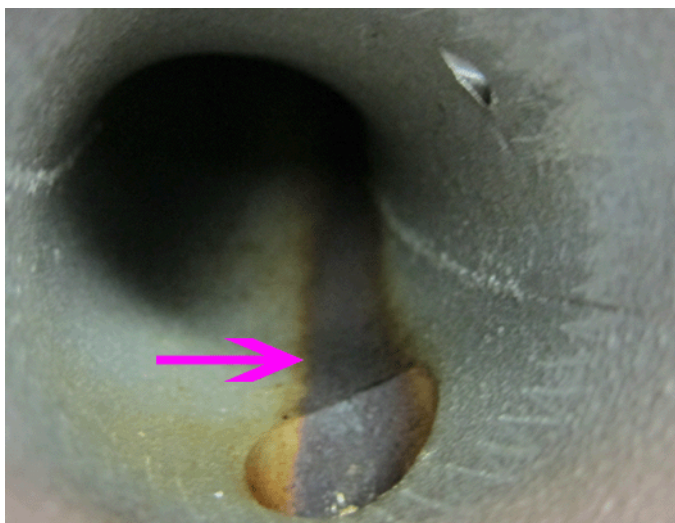
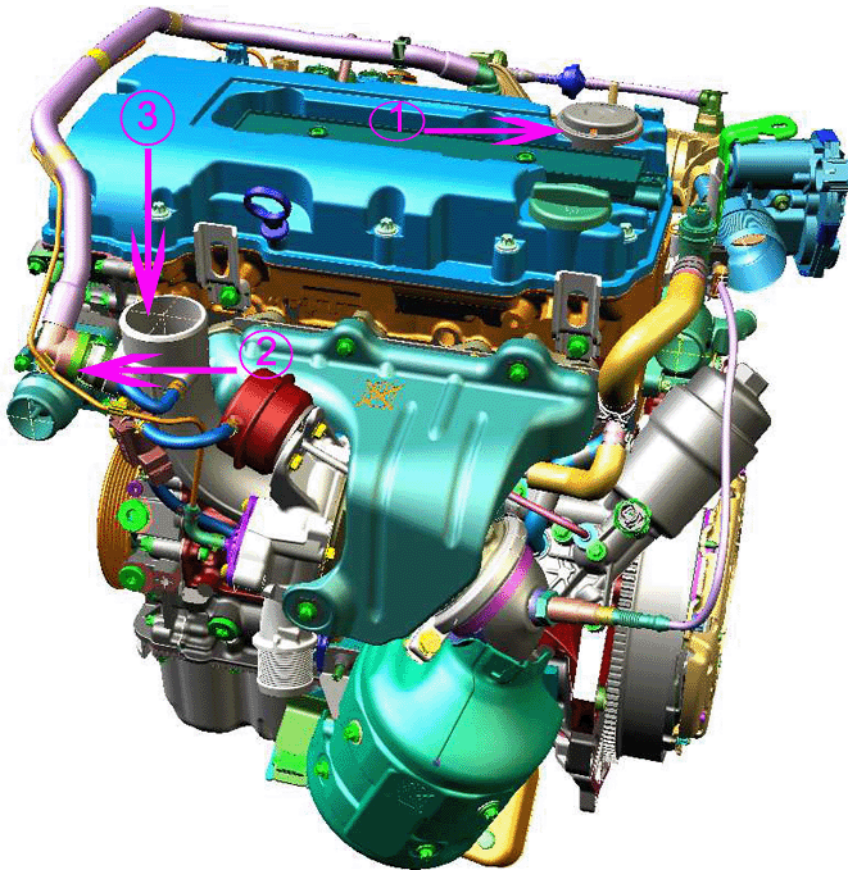
**Notice:** The views shown in the graphics are for identifying NORMAL oil staining in the opening for the PCV fresh air intake hose and the stain travel into the TC bore and DO NOT represent an oil leak.

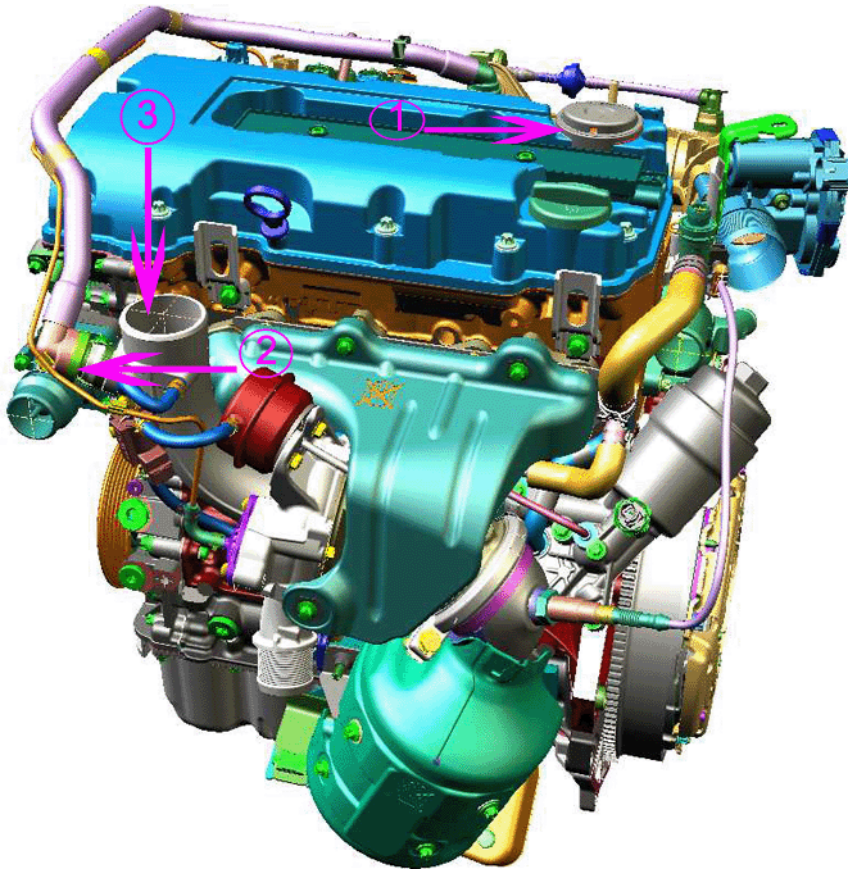
7. Inspect the inside of the TC outside air inlet tube (3) for oil leaking into the opening in the TC bore for the PCV fresh air intake hose.
  - ⇒ If oil is leaking into the opening in the TC bore for the PCV fresh air intake hose, proceed to Step 8.
  - ⇒ If oil is not leaking into the opening in the TC bore for the PCV fresh air intake hose, proceed to Step 10.

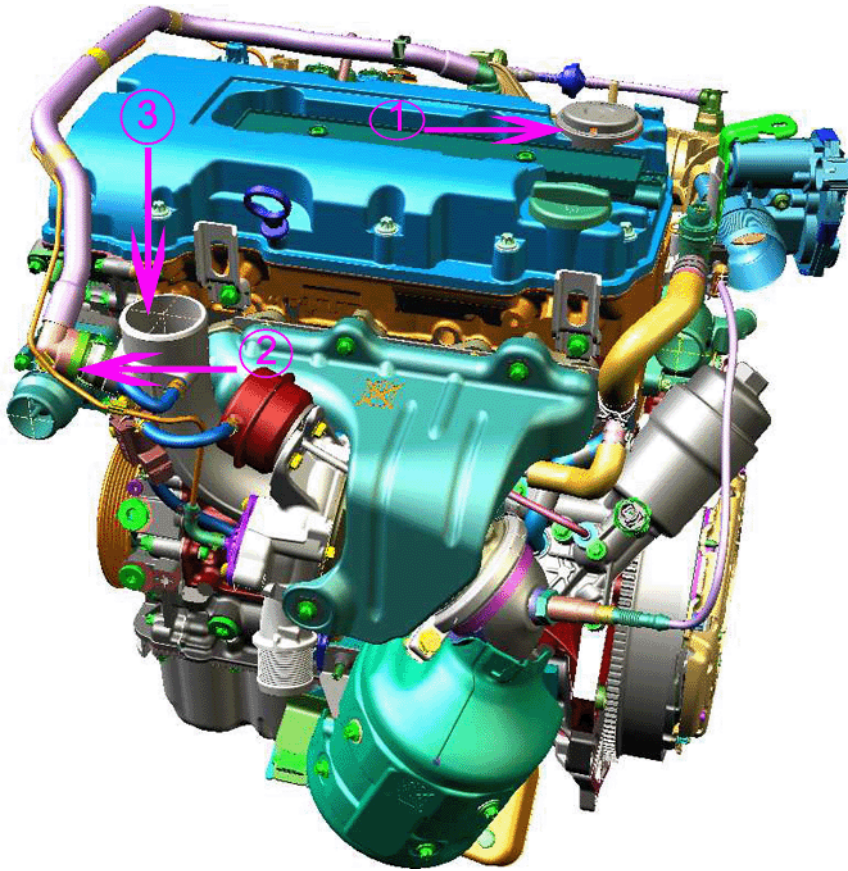
9. Inspect the inside of the PCV hose for oil.

⇒ If the PCV hose has oil in it, then replace the positive crankcase ventilation valve (1).

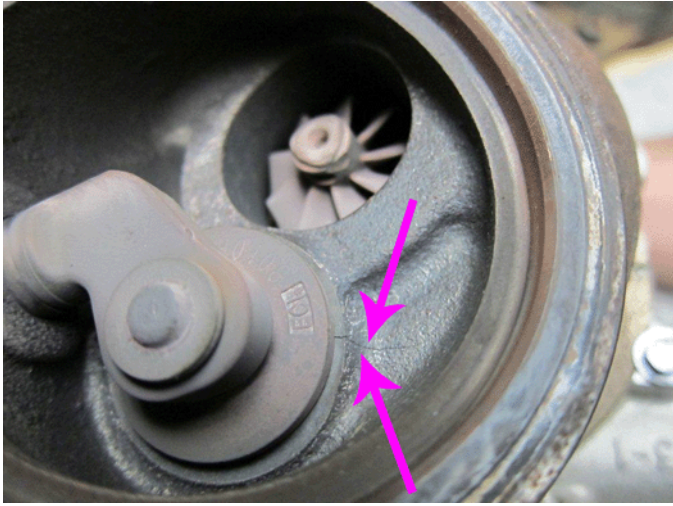
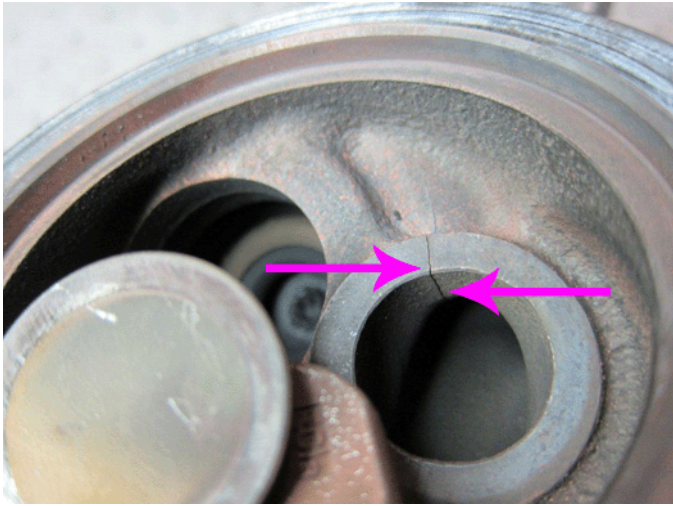
The presence of cracks in the TC wastegate valve port area is considered a normal condition, and will not affect the performance of the TC. **DO NOT** return the TC to the WPC for this condition.
