Service Bulletin

PRELIMINARY INFORMATION

Subject: Sharp Metal Edge Across Top of Rear Compartment Opening (Rear Window Panel)

Models: 2013-2015 Chevrolet Malibu

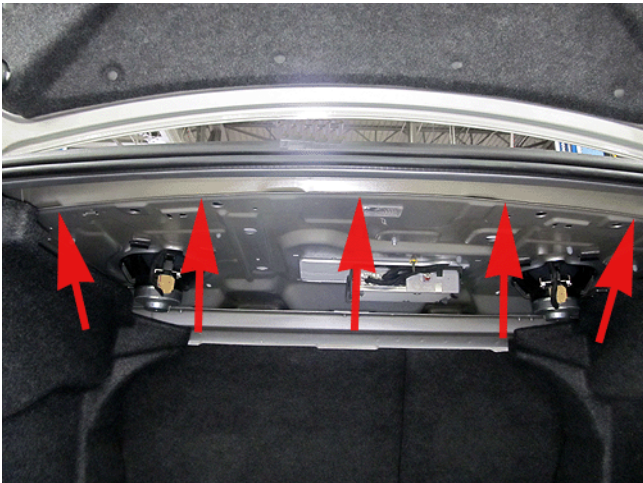
Some customers may comment that there is a sharp metal edge across the inside top area of the rear compartment opening. During the manufacturing process, a metal burr may have been left on the rear edge of the rear window panel.
