Service Bulletin

PRELIMINARY INFORMATION

Subject: Blank Screen After Startup and Reverse, Rearview Camera Message On, Touch Screen Inoperable, Bluetooth® and Navigation Concerns

Models: 2014 Buick LaCrosse, Regal
 2013-2014 Cadillac ATS, SRX, XTS
 2014 Cadillac CTS Sedan (VIN A), ELR
 2015 Cadillac Escalade Models
 2014 Chevrolet Corvette, Impala (VIN 1), Silverado 1500
 2015 Chevrolet Silverado 2500/3500 (Without AVF), Suburban, Tahoe
 2014 GMC Sierra 1500
 2015 GMC Sierra 2500/3500 (Without AVF), Yukon Models
 Equipped with RPOs RAO (SRX Only), RAO + UA3/UY4, IO4, IO5, IO6

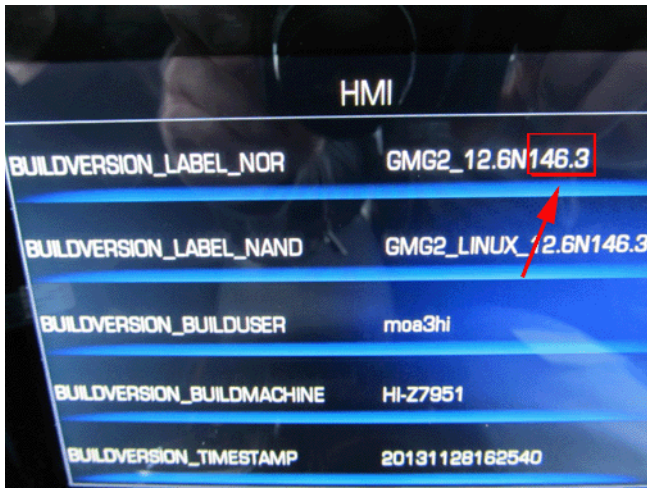
Before updating software, check the HMI build version. The HMI build version label should be GMG2.12.6N146.4 or earlier.

Note: The last 3.1 numbers as shown above will increase as the software gets updated. Those are the numbers to check when verifying software version.

Caution: If the software version is GMG2.12.6N146.4 or lower, proceed with this PI. If the version is higher, damage to the HMI module may occur. **DO NOT PROCEED WITH THIS PI** if the version is higher.
