Service Bulletin

Subject: Normal Characteristic - Rear Window Defogger Does Not Clear Upper Region Of Rear Window

Models: 2014 - 2015 Chevrolet Impala

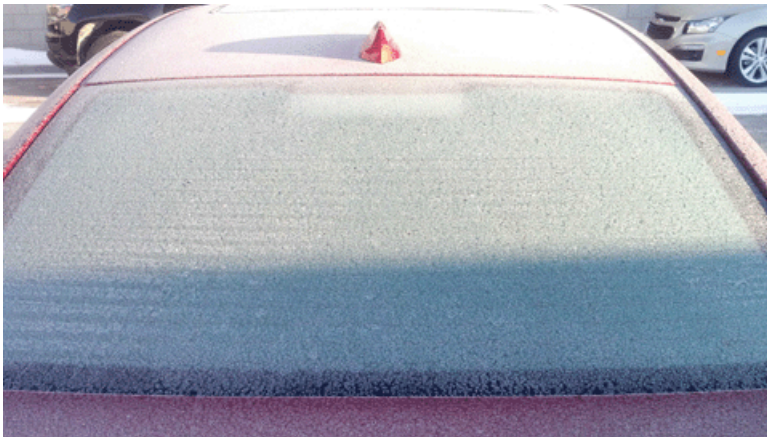
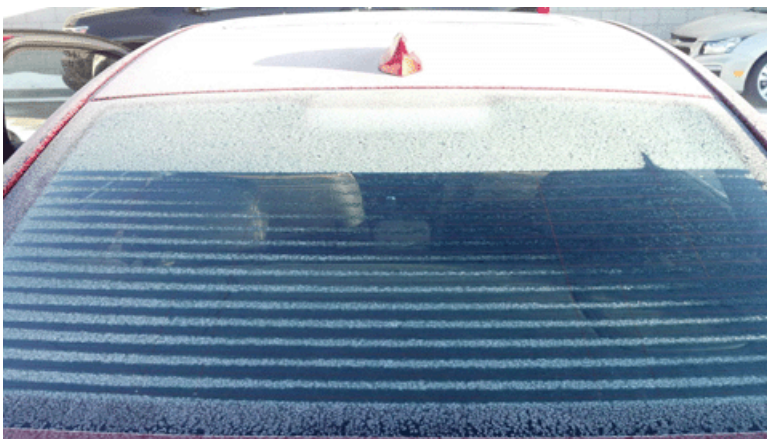
Some customers may comment when using the Rear Defogger the upper region of the rear window does not clear.

Please reference the pictures shown below which are examples of normal operation.

The upper region of gridlines on the rear window are antenna lines and are not intended to heat when the defogger is activated.

Important: If you experience the concern described above, no repairs are to be completed.

Please communicate to the customer this condition is a normal operating characteristic of their vehicle. It will not impact the designed performance or reliability of the vehicle. Please share this information with the customer, including a copy of this message.
