Service Bulletin

PRELIMINARY INFORMATION

Subject: Front Row Seat Back Appears To Lean Outward

Models: 2012-2014 Chevrolet Tahoe, Suburban
2012-2014 GMC Yukon Models

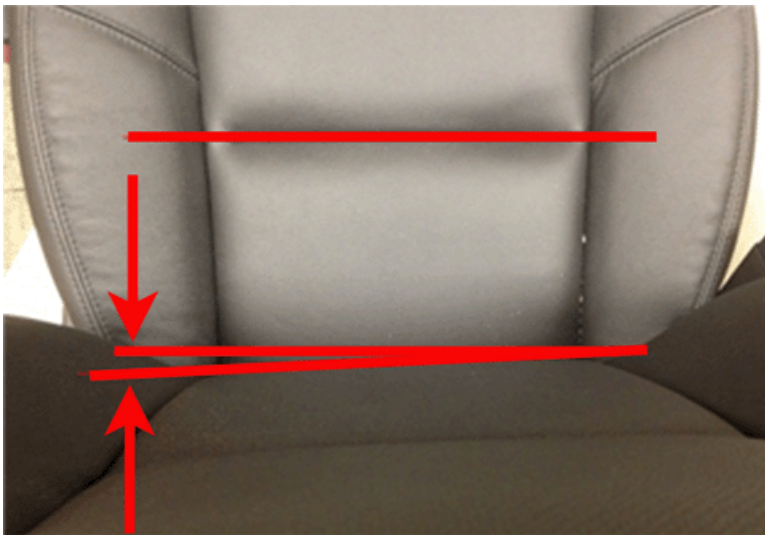
Some customers may state that the front driver's or passenger's seat back may appear to lean or to be turned outward, as shown below.
