Service Bulletin

PRELIMINARY INFORMATION

Subject: Front Row Seat Back Appears To Lean Outward (Seat Cover Improperly Installed)

Models: 2015 Cadillac Escalade Models
2014 Chevrolet Silverado 1500
2015 Chevrolet Silverado, Suburban, Tahoe
2014 GMC Sierra 1500
2015 Sierra, Yukon Models

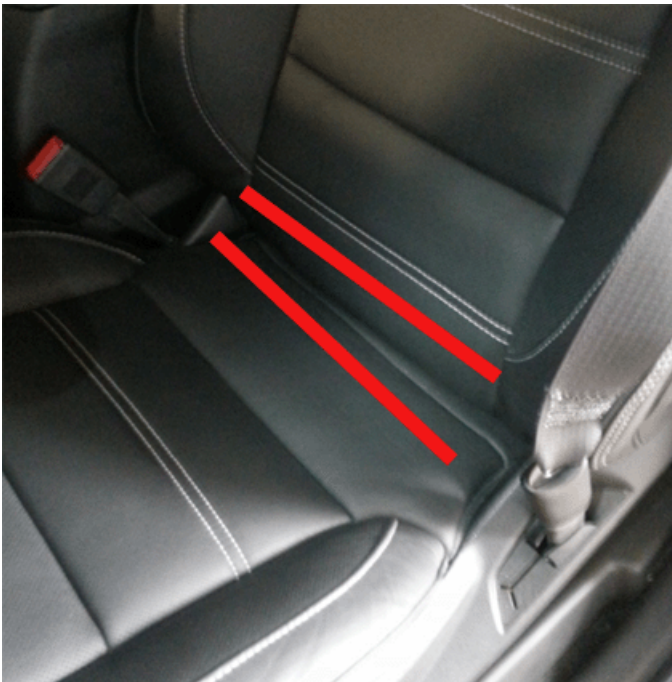
Some owners may perceive that the front driver's or passenger's seat back may lean or be turned outward, as shown below.

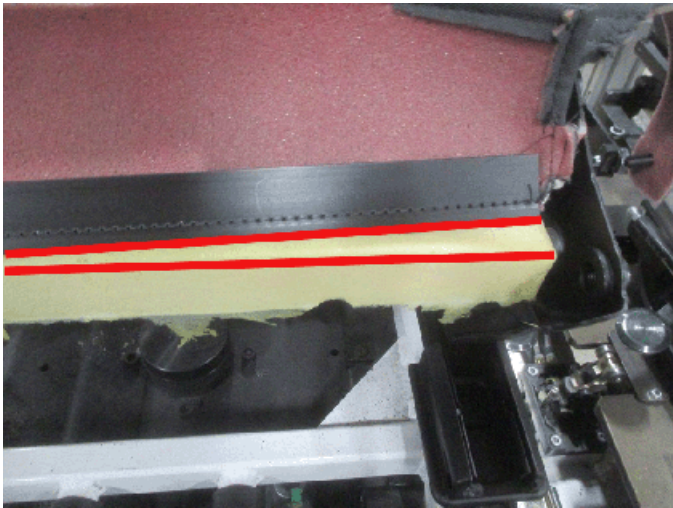
This concern could be caused by the seat bottom trim cover not installed correctly onto the cushion/foam, as shown below. If the seat cover is not completely and squarely installed onto the cushion/foam, it will give the appearance that the seat back is leaning or turned outward.
