Service Bulletin

Subject: Belt Noise Rough Idle and/or SES Light with DTC P0014 and/or P0017 - Inspect CMP Actuator Solenoid And Crankshaft End Play

Models: 2004-2009 Chevrolet TrailBlazer
2004-2012 Chevrolet Colorado
2004-2011 GMC Envoy
2004-2012 GMC Canyon
2004-2009 Hummer H3
with an Inline 4, 5, or 6 Cylinder Engine
(RPO Codes L52, LK5 LL8 LLR LLV)

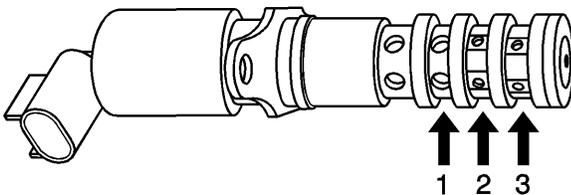
(1) Screen for Advance Pressure to Camshaft Actuator

- (2) Screen for Pressurized Oil from Oil Pump
- (3) Screen for Retard Pressure to Camshaft Actuator

If any of these screens are missing, replace the camshaft actuator solenoid, change the engine oil and filter, and re-evaluate the concern. If none of the screens are missing, proceed to step 2 below.
