# Service Bulletin

**Subject:** SPARK EV (BEV) 1ET35 Drive Unit and Component Restriction

**Models:** 2014 -2015 Chevrolet Spark EV (BEV)  
Equipped with 1ET35 Electric Drive Unit (RPO MME)

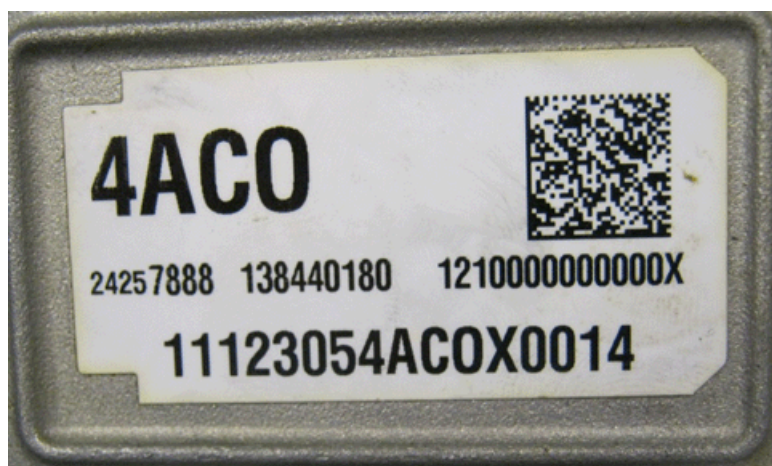
The Drive Unit Tag Number must be supplied to TAC when calling for a Drive Unit Assembly
