Service Bulletin

Subject: Radio Display Touchscreen Inoperative

Models: 2014-2015 Buick Regal

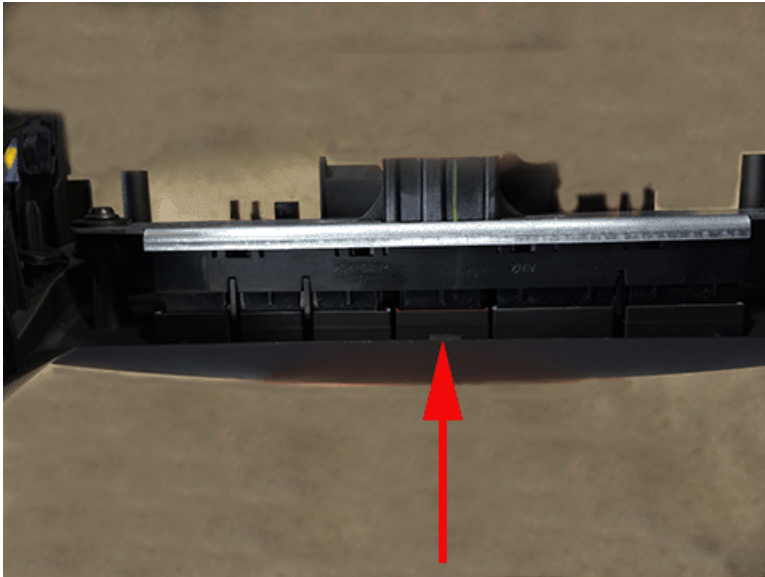
A customer may comment that the radio touchscreen is inoperative. This may be caused by the radio display bezel contacting the touchscreen at the top center of the display.

If this concern is encountered, remove the radio display bezel and Integrated Center Stack (ICS) from the dash, remove the bezel from the ICS, and re-connect the ICS in dash without the bezel. If the concern is still present, follow SI diagnostics for radio display malfunction and repair as necessary. If the concern is no longer present, inspect the inside top center of the bezel for a plastic tab that may be pressing on the display.

If the tab is found to be pressing on the display, carefully remove the tab using a sharp knife or equivalent by shaving the tab so that it is flush to outside edge of the bezel. Reassemble the display and bezel, and re-evaluate touchscreen operation.
