Service Bulletin

PRELIMINARY INFORMATION

Subject: Engine Vibration - Resonance/Boom Between 40 To 60 MPH

Models: 2010 - 2015 Chevrolet Equinox
2010 - 2015 GMC Terrain
Equipped With the 2.4 Cylinder Engine (RPO's LAF and LEA)

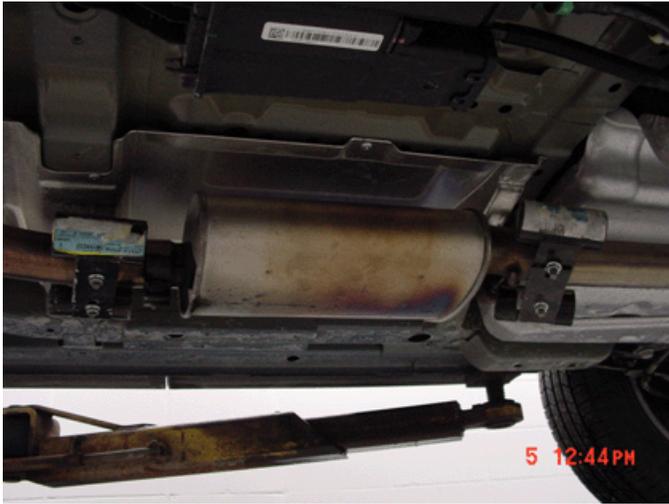
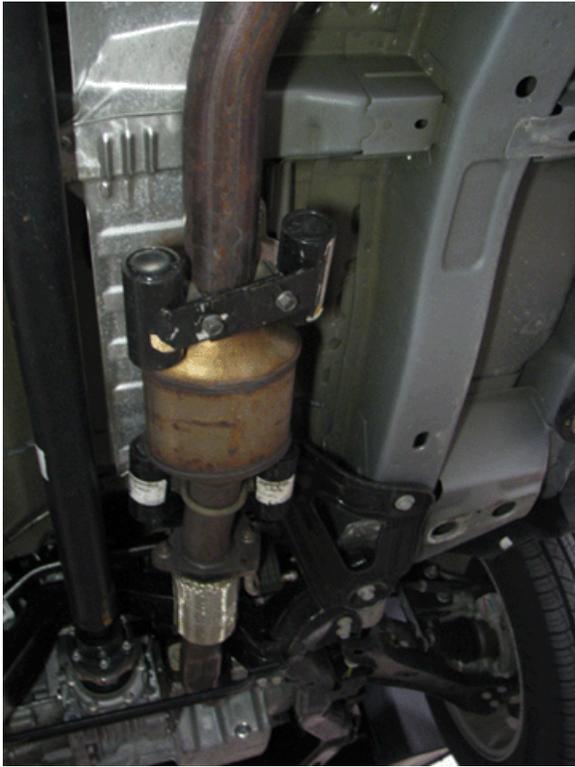
Some customers may comment that a resonance type vibration occurs between 40 to 60 MPH

It also is described as a 2nd order engine boom or vibration. In most cases this is an inherent condition on 4 cylinder models, however in some cases this condition is much more amplified.

If additional steps are required place two sets of exhaust dampeners (part #10199232 and attach with 2 1/2" exhaust clamps, part #15595206) one set before and one set after the front catalytic converter.

It may be required to move the pair of dampeners along the exhaust system to get the best results (photos attached).

Fabricate 2 dampers using the following procedure:

1. Obtain 4 dampeners, Part Number 10199232.
2. Line up 2 dampeners so the dampener pipes are opposite of each other.
3. Line up one mounting hole from each dampener with the holes of an appropriate size exhaust clamp.
4. With all of the holes lined up, weld the flat portion of the dampeners together and to the flat part of the exhaust clamp.
5. Attach the dampeners to the exhaust system using exhaust clamps.
