# Service Bulletin

**Subject:** Inspect XM/Cellular Mobile Phone/OnStar® Antenna for Looseness or Damage, XM/Cellular/OnStar® Reception Performance Degraded, Rattle/Flutter/Squeak Noise, Wind Noise/Whistle at Highway Speeds, Water Leak on Headliner at Sunvisor

**Models:** 2010-2015 Cadillac Escalade Models  
2010-2013 Chevrolet Avalanche, Silverado LD Models  
2010-2015 Chevrolet Silverado HD, Suburban, Tahoe  
2010-2013 GMC Sierra LD Models  
2010-2015 GMC Sierra HD Models, Yukon Models

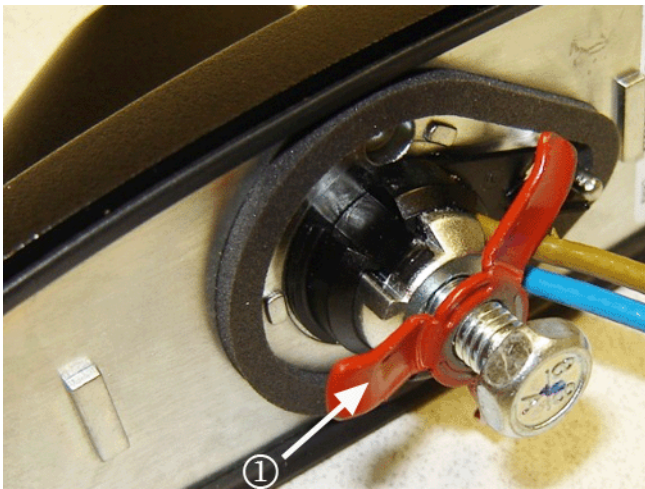
The cause of this condition may be looseness and/or damage of the XM/cellular mobile phone/OnStar® antenna, which may affect the grounding of the antenna and may allow a rattle/wind noise at highway speeds and/or a water leak.

Though difficult to detect evidence of impact damage, upon inspection of the antennas returned in warranty, there is a likelihood this damage occurred during vehicle transportation to dealerships. The result of impact damage is most often to the underside retainer (1), which is found to be bent backward or otherwise damaged and no longer provides proper retention.

If the antenna is loose or damaged, it must be replaced. Refer to Cellular Communications/Digital Radio Antenna Replacement in SI.
