Service Bulletin

Subject: Information for No Start Due to Inoperative LPG Fuel Pump Resulting from Upfitter Modifications

Models: 2012-2015 Chevrolet Express
2012-2015 GMC Savana
Equipped with Liquefied Petroleum Gas (LPG) – RPO KO7

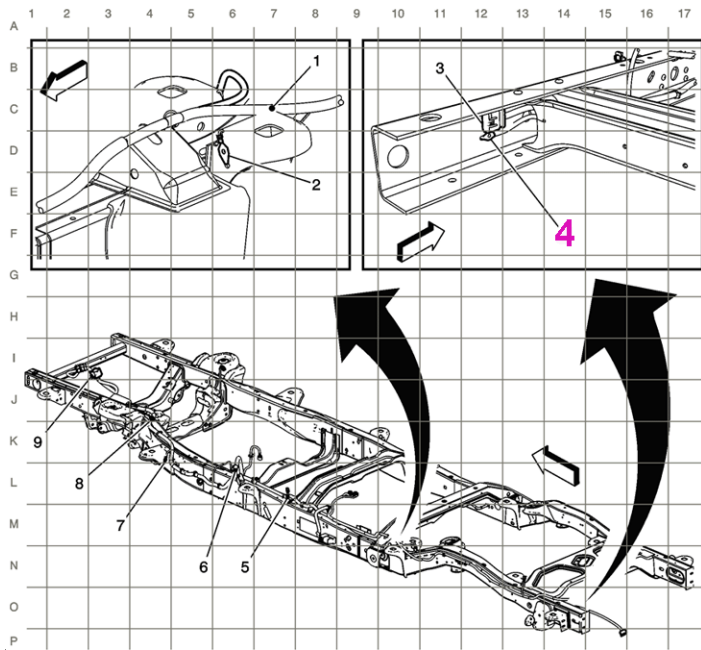
1. Review the original OEM location of G400 (4) in the graphic. The new G400 location selected by the upfitter will be in this general area of the chassis frame.

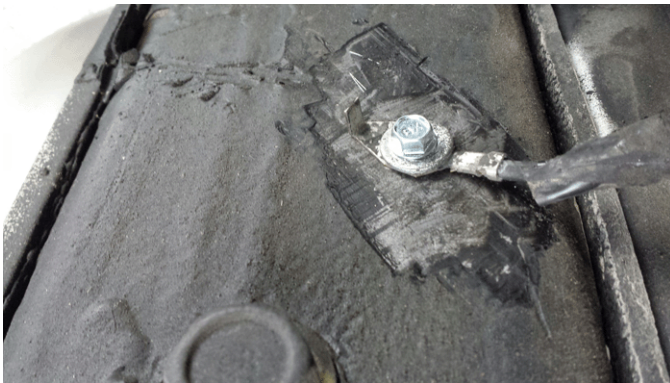
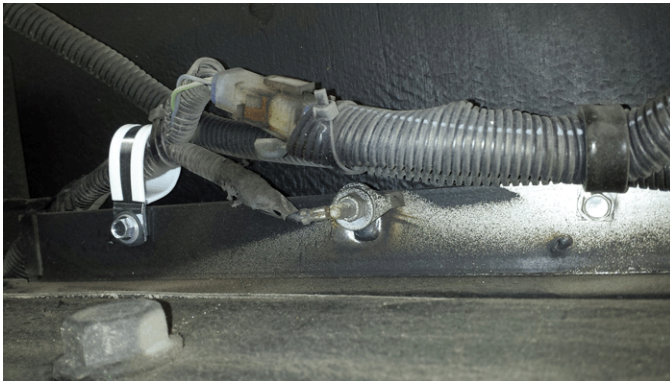
2. Review the graphics of the several new G400 locations that were possibly selected for use by the upfitter on the chassis frame in order to become familiar with the various locations.

3. Using GM approved residue-free solvent or equivalent, remove any grease from the G400 terminal.
4. Disconnect and remove the G400 terminal from the chassis frame.

5. Carefully remove any corrosion from both sides of the G400 terminal.
6. Using GM approved residue-free solvent or equivalent, remove any grease from the area and allow to dry.

7. Carefully remove any factory coating from the area until clean bare metal is visible.
8. Prep the repair area, as outlined in the Recommendations/Instructions in the latest version of PI0564: Wax Coating on Frame Peeling, Metal Shows Corrosion/Rusting.

10. Using a small brush, apply Dielectric Lubricant to both sides of the G400 terminal, install and secure as needed.
11. Perform the corrosion control procedure as outlined in the Recommendations/Instructions in the latest version of PI0564.

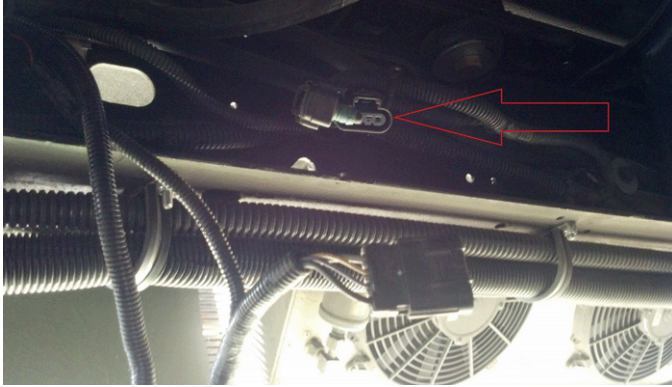
1. Disconnect the LPG fuel pump connector X350.

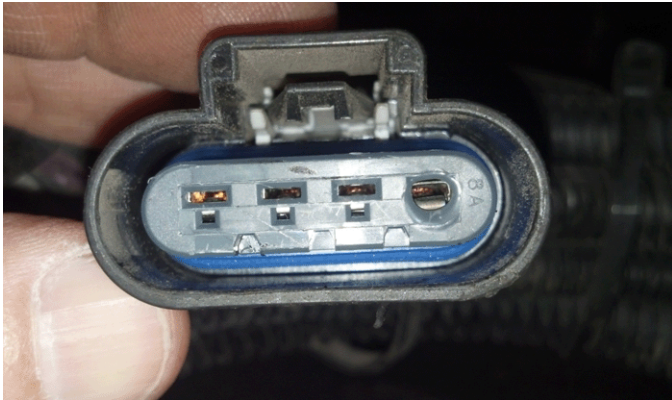
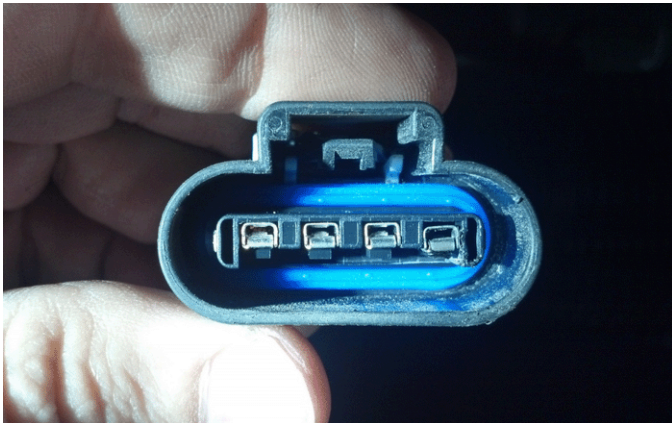
2. The X350 connector is shown with the plastic insert in position and then removed. Inspect the X350 connector for intermittent conditions and poor connections. Refer to Testing for Intermittent Conditions and Poor Connections in SI.
 - ⇒ If intermittent conditions and poor connections are found, repair as needed. Refer to Repairing Connector Terminals, Connector Repairs and Wiring Repairs in SI.
