Service Bulletin

Subject: Engineering Information – Battery Saver Active Message Displayed on DIC, Drive Motor Generator Belt Broken, DTC P1A6F or P0A90 May be Set

Models: 2013-2014 Buick LaCrosse, Regal
2013-2014 Chevrolet Malibu
Equipped with eAssist (RPO LUK)

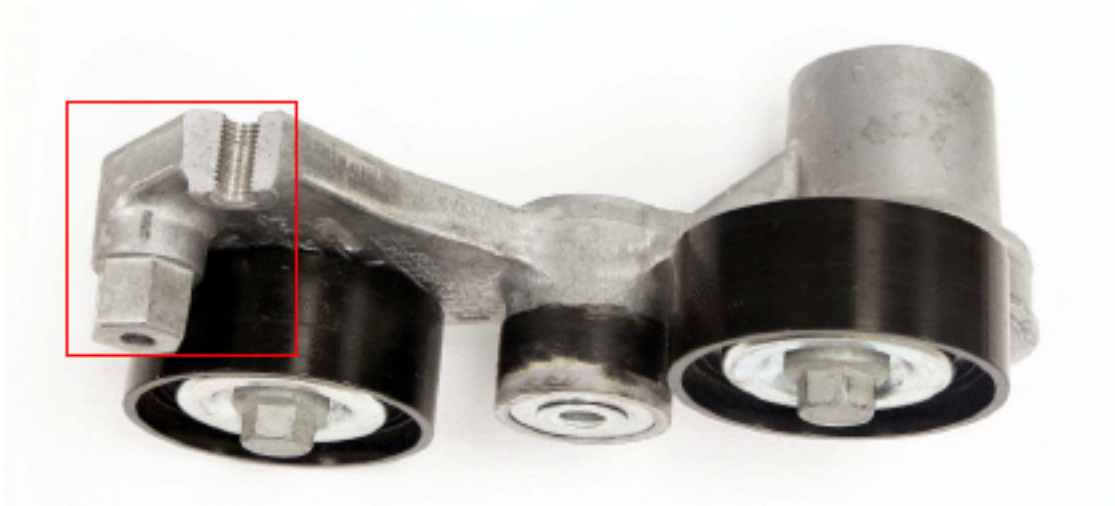
Further inspection may reveal that the drive motor generator unit (MGU) belt is broken or the tensioner is broken at the hydraulic tensioner attachment boss (shown below).

If you encounter a vehicle with the above concern, inspect the MGU belt and tensioner. If the belt looks like it was cleanly snapped or if the tensioner is broken at the attachment boss (shown below), contact the engineer listed below for further instructions.
