## PRODUCT CAMPAIGN BULLETIN

**APPLICABILITY:** 2004-2005 Subaru Impreza, WRX, STI

**SUBJECT:** Takata Front Passenger Air Bag  
 Inflator Replacement

**NUMBER:** WQR-53R

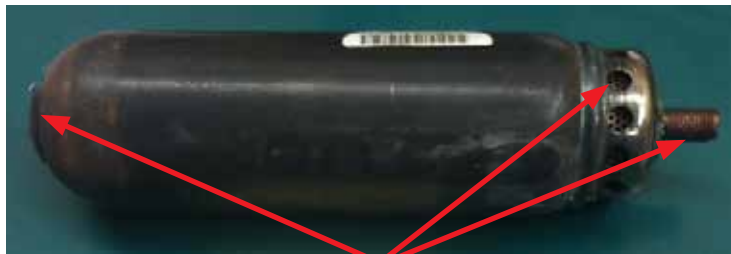
The shape, holes, and copper-colored stud indicate this not a Genuine Subaru inflator.

- If an aftermarket or counterfeit passenger airbag or inflator is identified at any point during the campaign service procedure, **STOP IMMEDIATELY. NEVER attempt to remove or otherwise disable any aftermarket or counterfeit device.**

- Document the presence of the aftermarket or counterfeit device on the repair order and with photos. Report this information immediately on a Quality Monitoring Report (QMR).

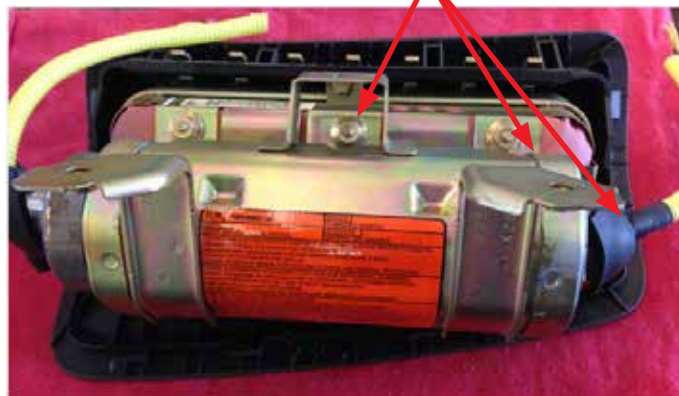
No visible stopper plates, a 6-nut configuration and rubber harness boots are other examples to indicate this is not a Genuine Subaru airbag module.
