SERVICE BULLETIN

APPLICABILITY: 2015 WRX and STI Models

NUMBER: 12-186-15

SUBJECT: Paint Chipping between Hood Grille (Scoop)
and Hood

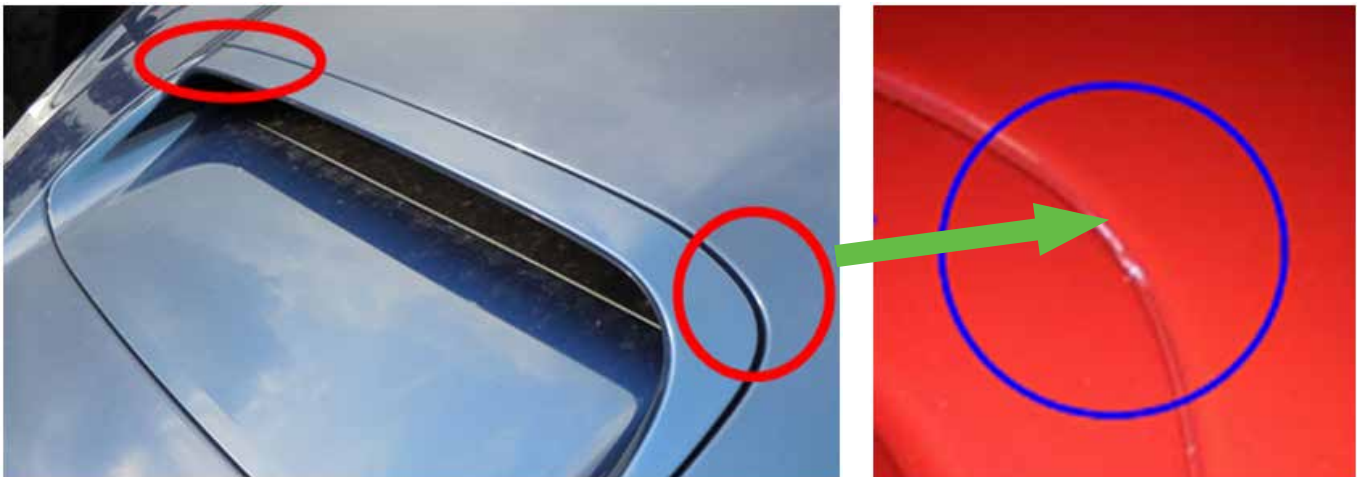
This bulletin announces a repair procedure to address customer concerns of the hood scoop scrubbing the finish of the hood panel in the areas shown in the photo below. Due to different expansion rates between the metal hood panel and the resin material used for the hood scoop, the edges of the scoop's rear corners may come in contact with the hood panel and abrade the finish. The procedure involves installation of 2 pieces of self-adhesive rubberized material to act as protectors (insulators) between the scoop and hood panel.
