Constellation
Heritage
> 4700 Models

Western Star
Service Bulletin

General Information

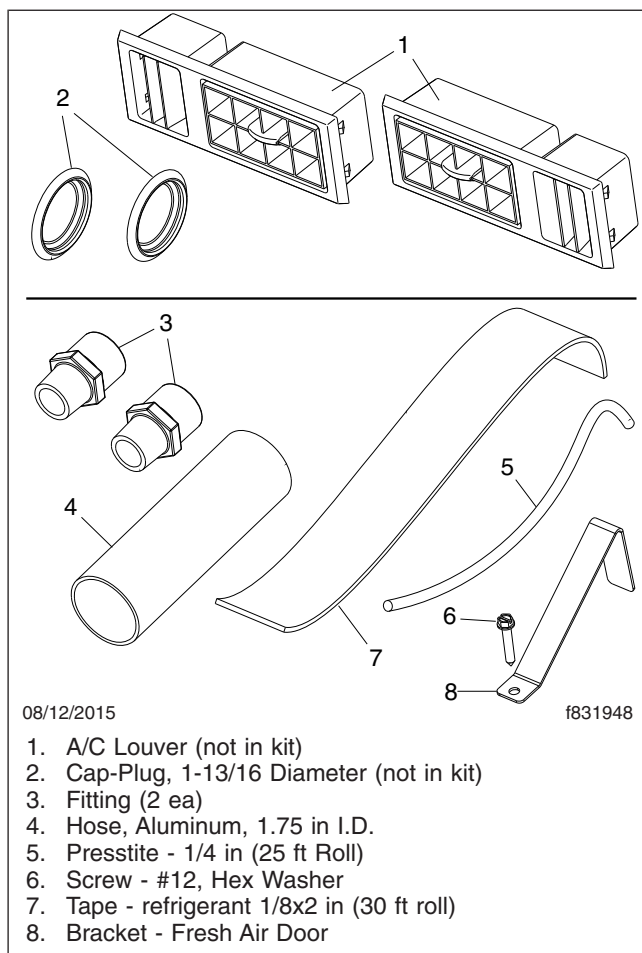
Fig. 1, Side Window Defrost Retrofit Parts

This procedure improves the side window defrost function and overall A/C performance on Western Star 4700, 4800, 4900, 5700, 6900 models. In extreme cold conditions, the side windows may ice up and limit visibility. A retrofit kit (WWS RD-3-19025-0P) is available to remedy the side window issue. See [Fig. 1](#) for installation parts. Installation of the new louvers directs air flow to the side windows. Installing the fresh-air door-stop bracket, and sealing leaks in the A/C ducting, significantly improves air flow in heater/defrost and cooling modes, providing noticeable improvement in overall system performance.

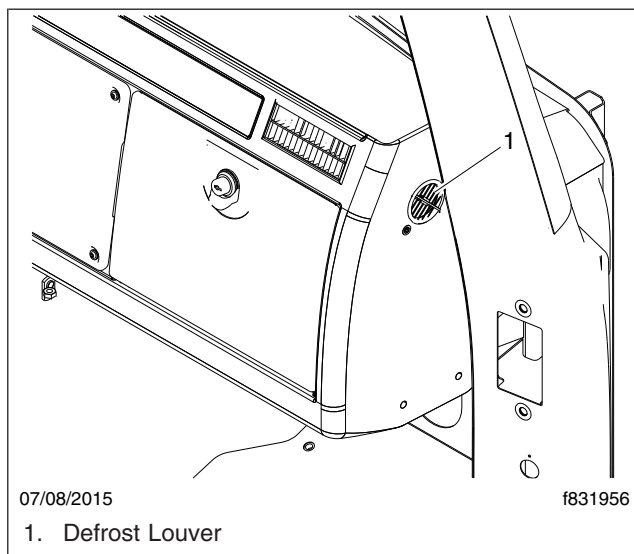
Fig. 6, Defrost Louver

NOTE: Some vehicles may have a round defrost louver outlet on the end of the dash facing the door panel. These outlets must be blocked.

5. If installed, remove the round defrost louvers at each end of the dash and install plugs in the holes. See [Fig. 6](#).

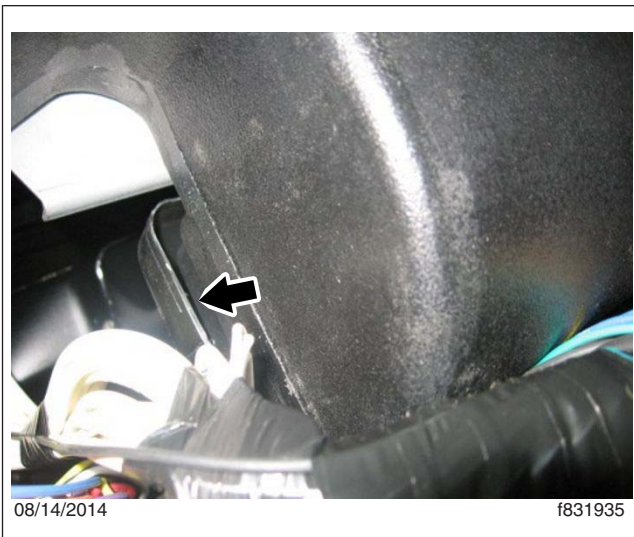
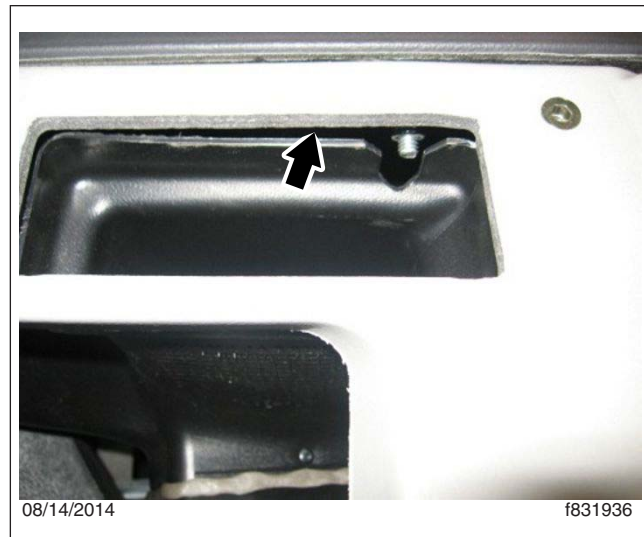
Fig. 7, Example of Gap

Fig. 8, Example of Gap

6. Seal any accessible duct-to-plenum interface leaks.
 - 6.1 If not already done, open the instrument panel, the auxiliary instrument panel, and remove the fuse panel cover.

- 6.2 Temporarily tape closed all of the in-dash louvers.
- 6.3 Set the mode switch to blow from the dash panel, and turn on the fan switch.
- 6.4 Check for air leaks at all accessible interfaces between the ducting and plenums.

Depending on the size of the gap, seal the connections with either RD-5-4092 Presstite Bead, or RD-5-4058 Refrigeration Tape or other suitable material.

- 6.5 Set the mode control switch to window defrost
- 6.6 Check for air leaks at all accessible interfaces between the ducting and plenums.
