# **Service Information Bulletin**

SUBJECT	DATE
SPN 520999/FMI 7 (TCM)	August 2015

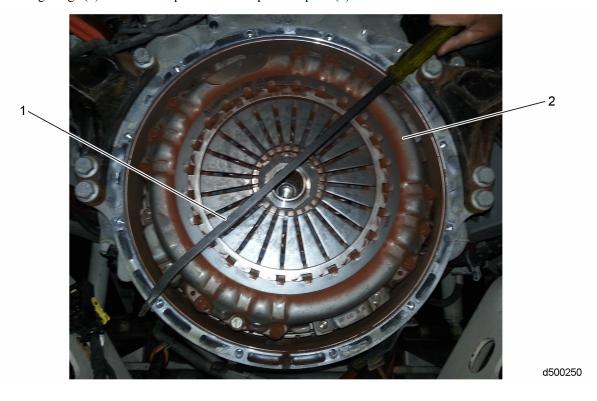
- a. Yes; Go to step 8.
- b. No; obtain a driving log file and contact the Detroit™ Customer Support Center at 855-253-0428 for further assistance.
- 8. Remove the transmission. Refer to section "Removal of the Transmission".
- 9. Keep the pressure plate and clutch disk installed on the engine.
  - **a.** Lay a straightedge (1) on the raised portions on the pressure plate (2).

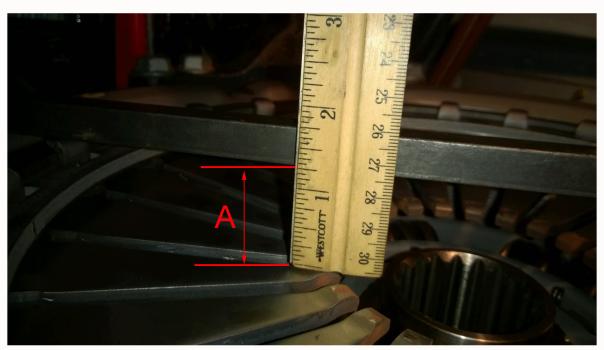
d500249

b. Use a ruler to measure the distance (A) from the straightedge to the contact apex of each release finger.

- 10. Is the measurement greater than 2.54 cm (1 in.) or pressure plate fingers warped?
  - a. Yes; replace pressure plate, pressure plate mounting bolts and clutch disc. Refer to section "Installation of the Clutch".
  - b. No; replace the Concentric Pneumatic Clutch Actuator (CPCA). Refer to section "Removal of the Clutch Actuator Assembly".
