## Service Information Bulletin

| SUBJECT | DATE |
|---|---|
| Symptom Diagnostics: Noisy One-Box Aftertreatment | February 2015 |

## 2 Symptom Diagnostics: Noisy One-Box Aftertreatment

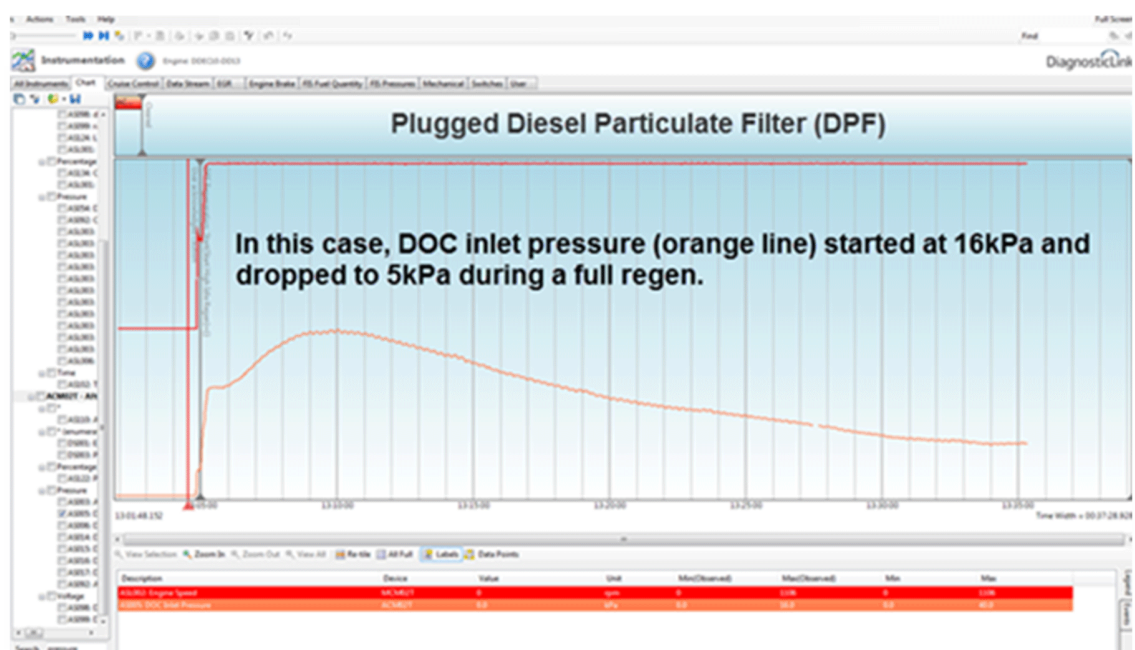
d500224

- a. If the DOC Inlet Pressure starts out high above 10 kPa (1.45 psi) and decreases during a parked regen, this indicates that the DPFs were plugged and the parked regen has cleared them. Go to step 10.

10. Verify the noise is gone and complete the ATD check list to possibly identify why the unit was plugged.  
For EPA10: Refer to section "EPA10 Perform Performance Check - Low Temperature ATD"  
For GHG14: Refer to section "GHG14 Perform Performance Check - Low Temperature ATD"
11. DiagnosticLink 8.0 with Service Pack 1 contains a new service routine for trying to unplug the front face of the Diesel Oxidation Catalysts for both EPA10 and GHG14 units. Refer to section "EPA10 and GHG14 Diesel Oxidation Catalyst Face Cleaning"

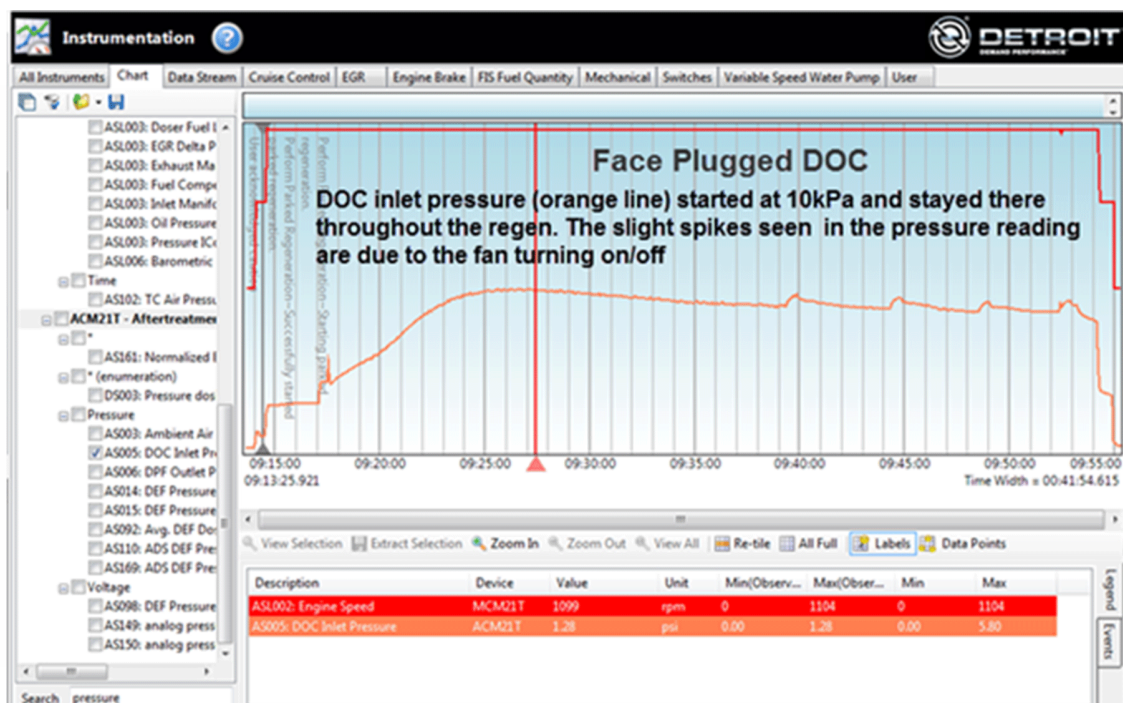
d500225

- b. If the DOC inlet pressure starts above the pressure specified below and stays high, the DOC is considered plugged. Go to step 11.

12. Since the DOC inlet pressure stayed steady and there is still a noise, run the DOC Face Unplugging procedure in DiagnosticLink under Actions-Aftertreatment. After completing the service routine, verify the noise is gone and release the vehicle.
13. If the aftertreatment is still noisy after running the DOC Face Unplugging procedure, replace the DOC/SCR module assembly.

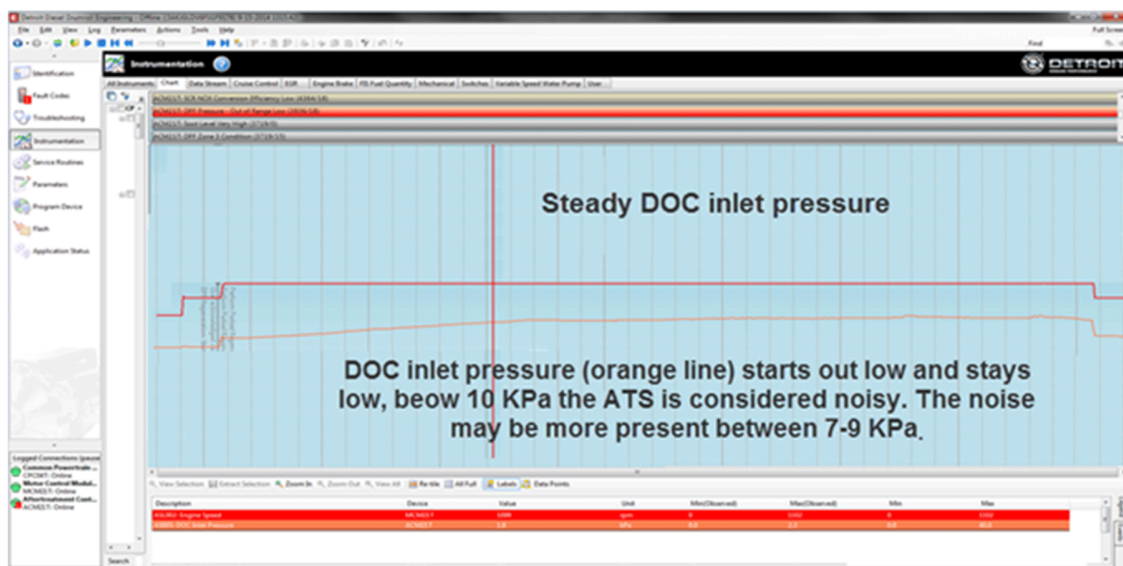
d500226

- c. If DOC inlet pressure starts out **low** and stays **low**, below 6 kPa (.87 psi), the Aftertreatment System (ATS) is considered noisy. Replace the DOC/SCR module, the module has failed internally.
