SERVICE BULLETIN

APPLICABILITY: 2013-14MY Impreza 2.0L NA Models
 2013-14MY XV Crosstrek, Including Hybrid Model (HEV)

NUMBER: 11-149-14R
DATE: 11/06/14
REVISED: 04/06/15

SUBJECT: Reprogramming File Availability for Oil Level Detection

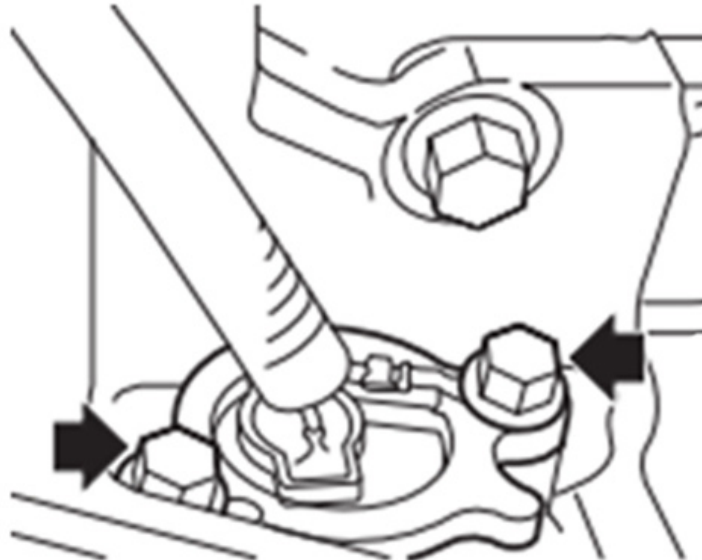
This bulletin announces the availability of reprogramming files and a revised oil level switch to optimize the ECM logic for engine oil level detection in the event of false or premature low engine oil level warning lamp illumination. Should a customer present a concern with a low engine oil warning lamp illumination and the diagnosis indicate the oil level is full or nearly full (oil level between the full and add marks/holes on the dipstick) and the customer has not added any engine oil, the ECM must be updated with this new logic and the oil level switch replaced. The new oil level switch part number supplied in this bulletin must be used. If the customer has added oil, determine how much was added. Based upon the information provided, estimate where the oil level was when the lamp illuminated in order to determine if additional action is required beyond what is described in this bulletin (e.g. an oil consumption test). The ECM must still be updated with this new logic and the oil level switch replaced.

Step 3 - Once the ECM reprogramming has been completed and the oil level switch wiring has been confirmed to be OK, proceed with replacing the oil level switch assembly shown in the illustration below following the procedure outlined in the applicable Service Manual. Torque the 2 retaining bolts to 6.4 Nm (56 inch-pounds). Torque the 2 retaining bolts to 6.4 Nm (56 inch-pounds).
