# 2013 OBD/GHG14, 6-Gallon DEF Header Suction Line Connection Broken by Ice Pressure

# 49-16

**Western Star  
Service Bulletin**

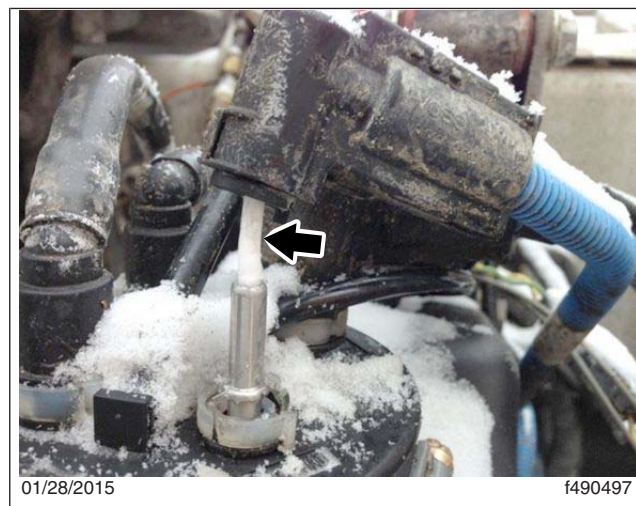
Under certain extreme cold ambient conditions, with the vehicle parked and shut off for an extended period, as the DEF freezes, ice expansion can break the DEF line fitting connected to the suction port of a 2013 OBD / GHG14 6-gallon DEF header. See [Fig. 1](#). For vehicles that are typically exposed to these kinds of conditions and have had the occurrence, a different suction stand pipe and DEF line design can be retrofitted using kit part number Z04-32079-000.

**Fig. 1, Ice Expansion at the DEF Line Fitting**

Replacing the suction stand pipe involves removing the header from the tank, disassembling the header and reassembling it with the new suction stand pipe that has smaller diameter and a larger fitting. With the larger fitting on the stand pipe, a different DEF line is required to connect to it.
