2013 OBD/GHG14, 6-Gallon DEF Header Suction Line Connection Broken by Ice Pressure

49-37

**Freightliner
Service Bulletin**

This bulletin applies only to vehicles with Cummins engines.

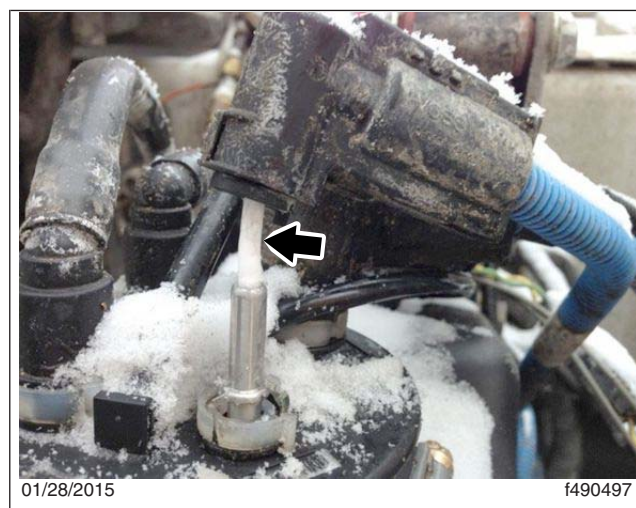
Under certain extreme cold ambient conditions, with the vehicle parked and shut off for an extended period, as the DEF freezes, ice expansion can break the DEF line fitting connected to the suction port of a 2013 OBD / GHG14 6-gallon DEF header. See [Fig. 1](#). For vehicles that are typically exposed to these kinds of conditions and have had the occurrence, a different suction stand pipe and DEF line design can be retrofitted using kit part number Z04-32079-000.

Fig. 1, Ice Expansion at the DEF Line Fitting

Replacing the suction stand pipe involves removing the header from the tank, disassembling the header and reassembling it with the new suction stand pipe that has smaller diameter and a larger fitting. With the larger fitting on the stand pipe, a different DEF line is required to connect to it.
